# Access Compliance Report Public Rights-of-Way (Curb Ramps)

Intersection ID: 10862	Main Street: N_GRAHAM_ST	Cross Street: DALTON_AV	Location: NW
ADA ID: 8DA28E0884E7	Ramp Type: Perp	Initial Pass/Fail: Fail	Overall Compliance: No
<b>Codes/Mitigation Info/Possible Solution</b>			<b>Field Measurements/Component Compliance</b>

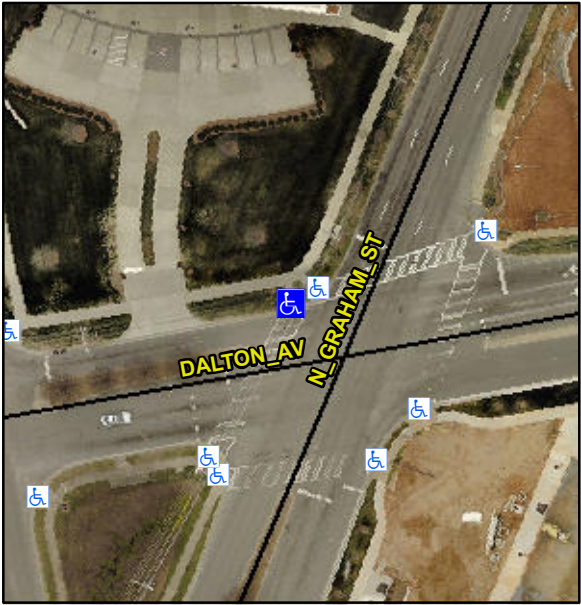
PROW/ADA:  
**Not Found, R304.5.1**

Compliance	Description	Data	Compliance	Description	Data
N/A	Ramp Length (in)	143.0	Yes	Ramp Slope (%)	6.0
No	Ramp Width (in)	47.5	Yes	Ramp XSlope (%)	3.0
N/A	Flare Type LT	N/A	N/A	Flare Type RT	N/A
N/A	Flare Slope LT (%)	N/A	N/A	Flare Slope RT (%)	N/A
N/A	Flare Traversable LT?	N/A	N/A	Flare Traversable RT?	N/A
N/A	Landing Length (in)	N/A	N/A	DWS Provided?	N/A
N/A	Landing Width (in)	N/A	N/A	DWS Contrast?	N/A
N/A	Landing Slope (%)	N/A	N/A	DWS Length (in)	N/A
N/A	Landing X Slope (%)	N/A	N/A	DWS Full Width?	N/A
N/A	Landing Curb? (Y/N)	N/A	N/A	DWS Offset (in)	N/A
N/A	Shared Landing?	N/A			
N/A	Gutter Ponding?	N/A	N/A	Gutter Slope (%)	N/A
N/A	Gutter Lip Ht (in)	N/A	N/A	Gutter X Slope (%)	N/A
N/A	Painted X Walk1?	Yes	N/A	Painted X Walk2?	N/A
	X Walk 1 Direction	To SW		X Walk 2 Direction	N/A
N/A	X Walk 1 Width (in)	140.0	N/A	X Walk 2 Width (in)	N/A
	X Walk 1 Slope (%)	0.3		X Walk 2 Slope (%)	N/A
	X Walk 1 X Slope (%)	4.9		X Walk 2 X Slope (%)	N/A

N/A	Ramp inside XWalk1?	Yes	N/A	Ramp inside XWalk2?	N/A
	Road Slope (%)	N/A	N/A	Clear Space?	N/A
	Road X Slope (%)	N/A	N/A	Clear Space to XWalk (in)	N/A
N/A	Any Obstructions?	N/A	N/A	Storm Grate/Utility Hazard?	N/A
	Obstruction Type			Storm Grate/Utility Type	
			N/A		N/A
			Yes	Surface Condition? (G/P)	Good

Possible Solutions:  
**Remove & Replace Entire Ramp.**

Total Cost: \$ 1850.00
