# Access Compliance Report

## Public Rights-of-Way

### (Curb Ramps)

Intersection ID: 52467	Main Street: ACQUINAS_PL	Cross Street: ST_JOHN_LN	Location:	N
ADA ID: 8DA55B0FB02B	Ramp Type: Perp	Initial Pass/Fail: Fail	Overall Compliance: No	Severity Score: 33.75

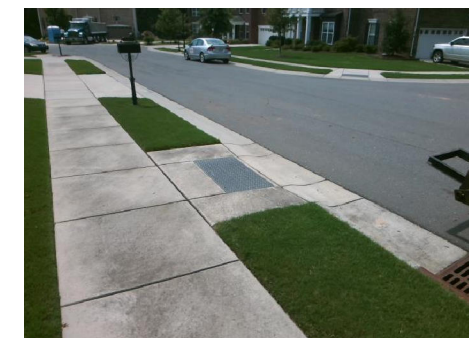
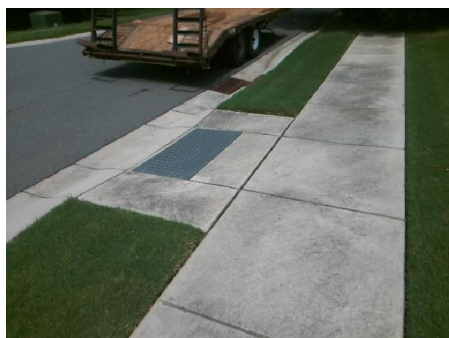
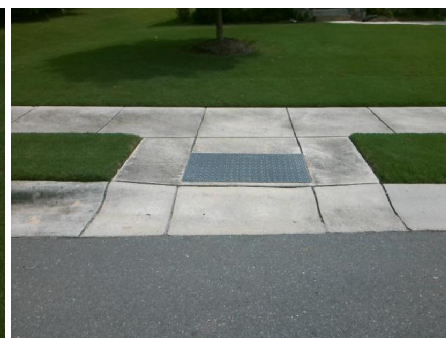
Compliance	Description	Data	Compliance	Description	Data
N/A	Ramp Length (in)	44.5	Yes	Ramp Slope (%)	4.0
No	Ramp Width (in)	47.0	No	Ramp XSlope (%)	8.2
N/A	Flare Type LT	N/A	N/A	Flare Type RT	N/A
N/A	Flare Slope LT (%)	N/A	N/A	Flare Slope RT (%)	N/A
N/A	Flare Traversable LT?	N/A	N/A	Flare Traversable RT?	N/A
N/A	Landing Length (in)	N/A	N/A	DWS Provided?	N/A
N/A	Landing Width (in)	N/A	N/A	DWS Contrast?	N/A
N/A	Landing Slope (%)	N/A	N/A	DWS Length (in)	N/A
N/A	Landing X Slope (%)	N/A	N/A	DWS Full Width?	N/A
N/A	Landing Curb? (Y/N)	N/A	N/A	DWS Offset (in)	N/A
N/A	Shared Landing?	N/A			
N/A	Gutter Ponding?	N/A	N/A	Gutter Slope (%)	N/A
N/A	Gutter Lip Ht (in)	N/A	N/A	Gutter X Slope (%)	N/A
N/A	Painted X Walk1?	No	N/A	Painted X Walk2?	N/A
	X Walk 1 Direction	To W		X Walk 2 Direction	N/A
N/A	X Walk 1 Width (in)	N/A	N/A	X Walk 2 Width (in)	N/A
	X Walk 1 Slope (%)	2.4		X Walk 2 Slope (%)	N/A
	X Walk 1 X Slope (%)	3.4		X Walk 2 X Slope (%)	N/A

N/A	Ramp inside XWalk1?	N/A	N/A	Ramp inside XWalk2?	N/A
	Road Slope (%)	N/A	N/A	Clear Space?	N/A
	Road X Slope (%)	N/A	N/A	Clear Space to XWalk (in)	N/A
N/A	Any Obstructions?	N/A	N/A	Storm Grate/Utility Hazard?	N/A
	Obstruction Type			Storm Grate/Utility Type	
		N/A			N/A
			Yes	Surface Condition? (G/P)	Good

**Remove & Replace Entire Ramp.**
