# Access Compliance Report

## Public Rights-of-Way

### (Curb Ramps)

Intersection ID: 29122	Main Street: CANDLE_LEAF_CT	Cross Street: CRISP_WOOD_LN	Location: SE
ADA ID: 8DB6AFF94455	Ramp Type: Perpendicular Diagonal	Initial Pass/Fail: Fail	Overall Compliance: No
Severity Score: 12.5			
Codes/Mitigation Info/Possible Solution		Field Measurements/Component Compliance

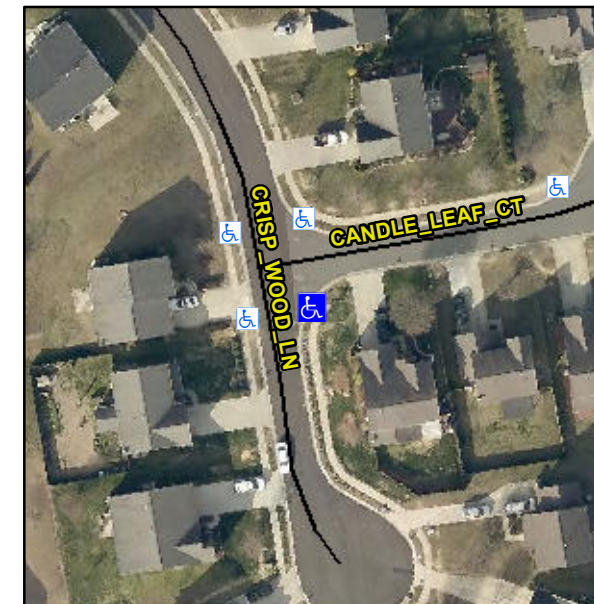
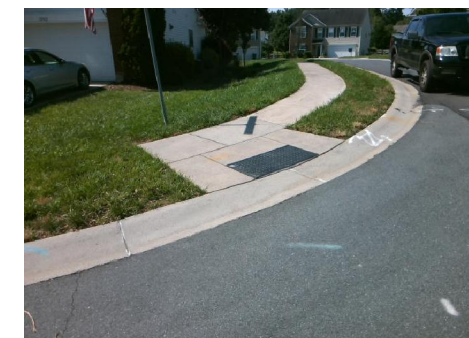
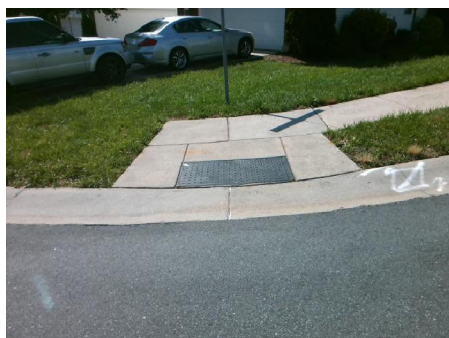
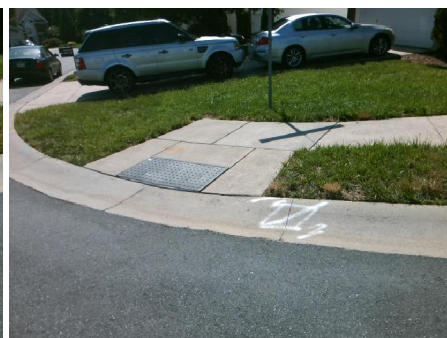
**Not Found, R304.5.3**

Compliance	Description	Data	Compliance	Description	Data
N/A	Ramp Length (in)	50.0	Yes	Ramp Slope (%)	6.5
Yes	Ramp Width (in)	48.0	No	Ramp XSlope (%)	5.8
N/A	Flare Type LT	N/A	N/A	Flare Type RT	N/A
N/A	Flare Slope LT (%)	N/A	N/A	Flare Slope RT (%)	N/A
N/A	Flare Traversable LT?	N/A	N/A	Flare Traversable RT?	N/A
N/A	Landing Length (in)	N/A	N/A	DWS Provided?	N/A
N/A	Landing Width (in)	N/A	N/A	DWS Contrast?	N/A
N/A	Landing Slope (%)	N/A	N/A	DWS Length (in)	N/A
N/A	Landing X Slope (%)	N/A	N/A	DWS Full Width?	N/A
N/A	Landing Curb? (Y/N)	N/A	N/A	DWS Offset (in)	N/A
N/A	Shared Landing?	N/A			
N/A	Gutter Ponding?	N/A	N/A	Gutter Slope (%)	N/A
N/A	Gutter Lip Ht (in)	N/A	N/A	Gutter X Slope (%)	N/A
N/A	Painted X Walk1?	No	N/A	Painted X Walk2?	No
	X Walk 1 Direction	To N		X Walk 2 Direction	To W
N/A	X Walk 1 Width (in)	N/A	N/A	X Walk 2 Width (in)	N/A
	X Walk 1 Slope (%)	2.2		X Walk 2 Slope (%)	5.4
	X Walk 1 X Slope (%)	7.6		X Walk 2 X Slope (%)	3.0

N/A	Ramp inside XWalk1?	N/A	N/A	Ramp inside XWalk2?	N/A
	Road Slope (%)	7.6	N/A	Clear Space?	N/A
	Road X Slope (%)	2.7	N/A	Clear Space to XWalk (in)	N/A
N/A	Any Obstructions?	N/A	N/A	Storm Grate/Utility Hazard?	N/A
	Obstruction Type			Storm Grate/Utility Type	
		N/A			N/A
			Yes	Surface Condition? (G/P)	Good

**Remove & Replace Curb Ramp With Two New Directional Ramps or Equivalent.**
