Access Compliance Report Public Rights-of-Way (Curb Ramps)

Intersection ID: 14200 Main Street: CLARICE_AV Cross Street: E_7TH_ST Location: Ε

Overall Compliance: No ADA ID: 8DB8BB4C9788 Ramp Type: Perp Initial Pass/Fail: Fail **Severity Score:** 12.5

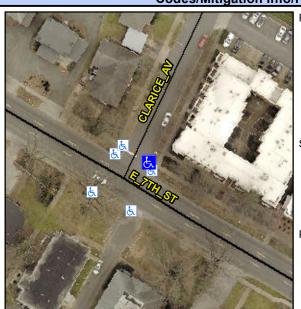
Comp	liance Description	Data	Comp	liance Desc	ription	Data
N/A	Ramp Length (in)	56.0	Yes	Ramp Slope	e (%)	7.5
Yes	Ramp Width (in)	48.0	No	Ramp XSlop	pe (%)	5.5
N/A	Flare Type LT	N/A	N/A	Flare Type F	RT	N/A
N/A	Flare Slope LT (%)	N/A	N/A	Flare Slope	RT (%)	N/A
N/A	Flare Traversable LT?	N/A	N/A	Flare Traver	sable RT?	N/A
N/A	Landing Length (in)	N/A	N/A	DWS Provid	led?	N/A
N/A	Landing Width (in)	N/A	N/A	DWS Contra	ast?	N/A
N/A	Landing Slope (%)	N/A	N/A	DWS Lengtl	h (in)	N/A
N/A	Landing X Slope (%)	N/A	N/A	DWS Full W	/idth?	N/A
N/A	Landing Curb? (Y/N)	N/A	N/A	DWS Offset	(in)	N/A
N/A	Shared Landing?	N/A				
N/A	Gutter Ponding?	N/A	N/A	Gutter Slope	∈ (%)	N/A
N/A	Gutter Lip Ht (in)	N/A	N/A	Gutter X Slo	ppe (%)	N/A
N/A	Painted X Walk1?	No	N/A	Painted X W	/alk2?	N/A
	X Walk 1 Direction	To NW		X Walk 2 Di	rection	N/A
N/A	X Walk 1 Width (in)	N/A	N/A	X Walk 2 W	idth (in)	N/A
	X Walk 1 Slope (%)	4.4		X Walk 2 Sl	ope (%)	N/A

X Walk 1 X Slope (%)	1.6		X Walk 2 X	Slope (%)	N/A
N/A	Ramp inside XWalk1?	N/A	N/A	Ramp inside	e XWalk2?	N/A
	Road Slope (%)	N/A	N/A	Clear Space	e?	N/A
	Road X Slope (%)	N/A	N/A	Clear Space	e to XWalk (in)	N/A
N/A	Any Obstructions?	N/A	N/A	Storm Grate	e/Utility Hazard?	N/A
	Obstruction Type			Storm Grate	e/Utility Type	
		N/A				N/A
			Yes	Surface Cor	ndition? (G/P)	Good

Possible Solutions:	<u>c</u>
Remove & Replace Entire Ramp.	N
	Ye
	N/
	N
	N
	N
Surveyor Notes:	N
N/A	N
	N
	N
	N
PROW/ADA:	N
Not Found, R304.5.3	N
,	N
	N

Total Cost:	\$	1850.00
