Access Compliance Report Public Rights-of-Way (Curb Ramps)

Intersection ID: 44419 Main Street: ARDREY_KELL_RD Cross Street: PROVIDENCE_RD Location: SE

ADA ID: 8DDF4F448967 Ramp Type: Perpendicular Initial Pass/Fail: Fail Overall Compliance: No Severity Score: 8.75

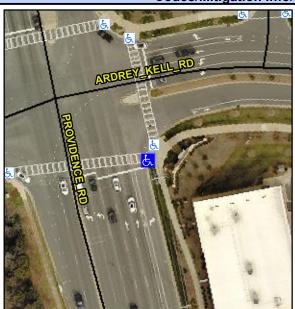
Not Found, R304.5.1

| Field Measurements/Component Compliance | | | | | |
|---|---|---|---|---|---|
| No | Ramp Width (in) | 47.5 | Yes | Ramp XSlope (%) | 2.0 |

Remove & Replace Entire Ramp.
