# Access Compliance Report

## Public Rights-of-Way

### (Curb Ramps)

| Intersection ID: 44217 | Main Street: HENNIGAN_PLACE_LN | Cross Street: ROZZELLES_LANDING_DR | Location: NW |

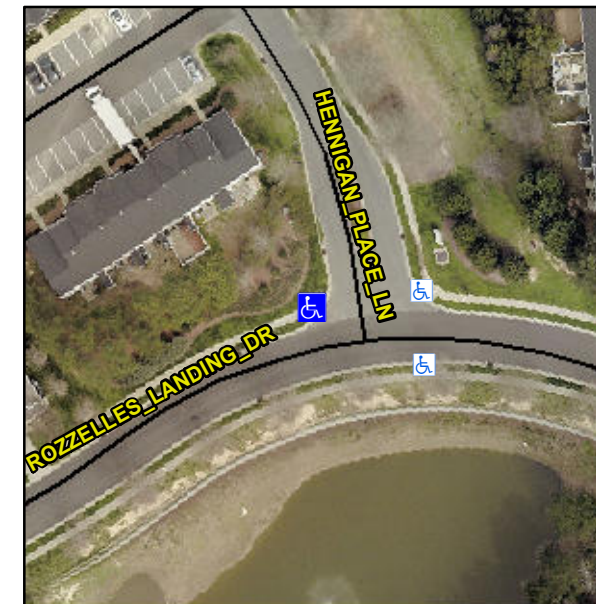
| ADA ID: 8DE4025F20F8 | Ramp Type: Perpendicular Diagonal | Initial Pass/Fail: Fail | Overall Compliance: No |
| Severity Score: 8.75 | | | |

**R304.5.1**

| Compliance | Description | Data | Compliance | Description | Data |
|---|---|---|---|---|---|
| No | Ramp Width (in) | 42.0 | Yes | Ramp XSlope (%) | 0.8 |

**Remove & Replace Curb Ramp With Two New Directional Ramps or Equivalent.**

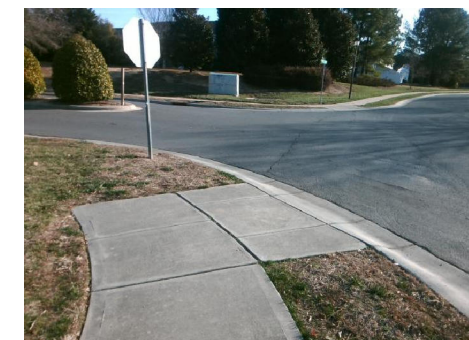
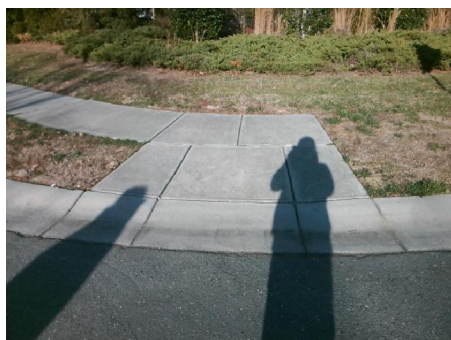
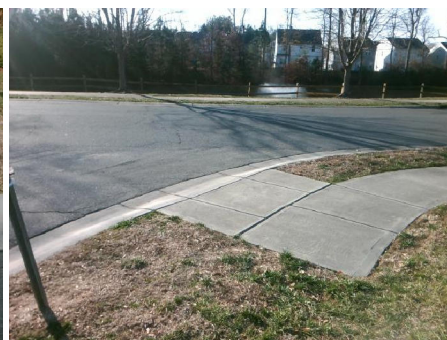
| Compliance | Description | Data | Compliance | Description | Data |
|---|---|---|---|---|---|
| N/A | Ramp Length (in) | 48.0 | Yes | Ramp Slope (%) | 6.5 |
