## **Access Compliance Report Public Rights-of-Way** (Curb Ramps)

Intersection ID: 13488 Main Street: E\_BLAND\_ST Cross Street: S\_COLLEGE\_ST Location: N **Severity Score: Overall Compliance: No ADA ID: 8DED8BE135E9** Ramp Type: Perpendicular Initial Pass/Fail: Fail 25

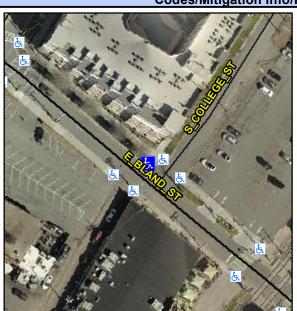
Field Measurements/Component Compliance								
Compl	iance Description	Data	Compl	iance	Description	Data		
N/A	Ramp Length (in)	67.0	Yes	Ramp	Slope (%)	5.6		
Yes	Ramp Width (in)	48.0	No	Ramp	XSlope (%)	8.6		
N/A	Flare Type LT	N/A	N/A	Flare	Type RT	N/A		
N/A	Flare Slope LT (%)	N/A	N/A	Flare	Slope RT (%)	N/A		
N/A	Flare Traversable LT?	N/A	N/A	Flare	Traversable RT?	N/A		
N/A	Landing Length (in)	N/A	N/A	DWS	Provided?	N/A		
N/A	Landing Width (in)	N/A	N/A	DWS	Contrast?	N/A		
N/A	Landing Slope (%)	N/A	N/A	DWS	Length (in)	N/A		
N/A	Landing X Slope (%)	N/A	N/A	DWS	Full Width?	N/A		
N/A	Landing Curb? (Y/N)	N/A	N/A	DWS	Offset (in)	N/A		
N/A	Shared Landing?	N/A						
N/A	Gutter Ponding?	N/A	N/A	Gutte	er Slope (%)	N/A		
N/A	Gutter Lip Ht (in)	N/A	N/A	Gutte	er X Slope (%)	N/A		
N/A	Painted X Walk1?	No	N/A	Paint	ed X Walk2?	N/A		
	X Walk 1 Direction	To SW		X Wa	lk 2 Direction	N/A		
N/A	X Walk 1 Width (in)	N/A	N/A	X Wa	lk 2 Width (in)	N/A

X Walk 1 Slope (%)	6.2		X Wa	lk 2 Slope (%)	N/A		
	X Walk 1 X Slope (%)	6.8		X Wa	lk 2 X Slope (%)	N/A		
N/A	Ramp inside XWalk1?	N/A	N/A	Ram	o inside XWalk2?	N/A		
	Road Slope (%)	N/A	N/A	Clear	Space?	N/A		
	Road X Slope (%)	N/A	N/A	Clear	Space to XWalk (in)	N/A		
N/A	Any Obstructions?	N/A	N/A	Storn	n Grate/Utility Hazard?	N/A		
	Obstruction Type			Storn	n Grate/Utility Type			
		N/A				N/A		
			Yes	Surfa	ce Condition? (G/P)	Good

Fossible Solution						
Possible Solutions:						
Remove & Replace Entire Ramp.						
Surveyor Notes:						
N/A						
PROW/ADA:						
Not Found, R304.5.3						
not i dana, not not
