# Access Compliance Report

## Public Rights-of-Way

### (Curb Ramps)

| Intersection ID: 43884 | Main Street: JOHN_ADAMS_RD | Cross Street: ADAMS_PLACE_RD | Location: NE |

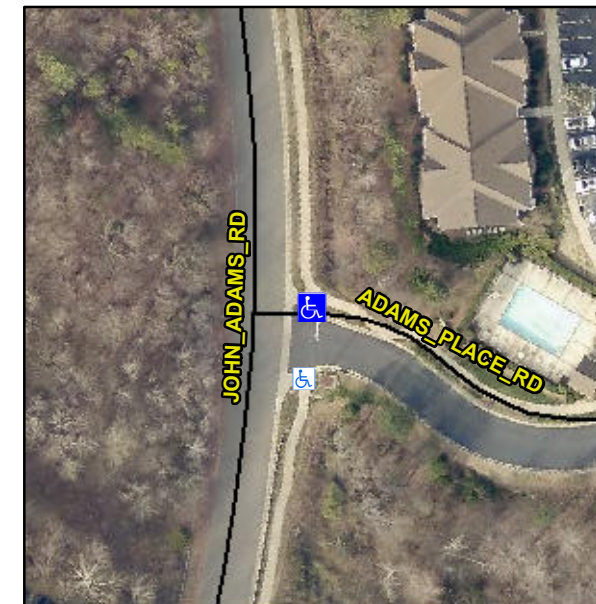
| ADA ID: 8DEF59F17A06 | Ramp Type: Perpendicular | Initial Pass/Fail: Fail | Overall Compliance: No |
| | | Severity Score: 35 | |

**R304.5.1, R304.2.2, R304.5.3**

| Compliance | Description | Data | Compliance | Description | Data |
|---|---|---|---|---|---|
| N/A | Ramp Length (in) | 68.0 | No | Ramp Slope (%) | 13.0 |
| No | Ramp Width (in) | 43.0 | No | Ramp XSlope (%) | 4.2 |

**Remove & Replace Entire Ramp.**

**\$ 1850.00**
