# Access Compliance Report

## Public Rights-of-Way

### (Curb Ramps)

Intersection ID: N/A	Main Street: YORKMONT_RD	Cross Street: N/A	Location: W
ADA ID: 8DFB6C13B824	Ramp Type: BlendTrans1	Initial Pass/Fail: Pass	Overall Compliance: No
		Severity Score: 0	
Codes/Mitigation Info/Possible Solution		Field Measurements/Component Compliance

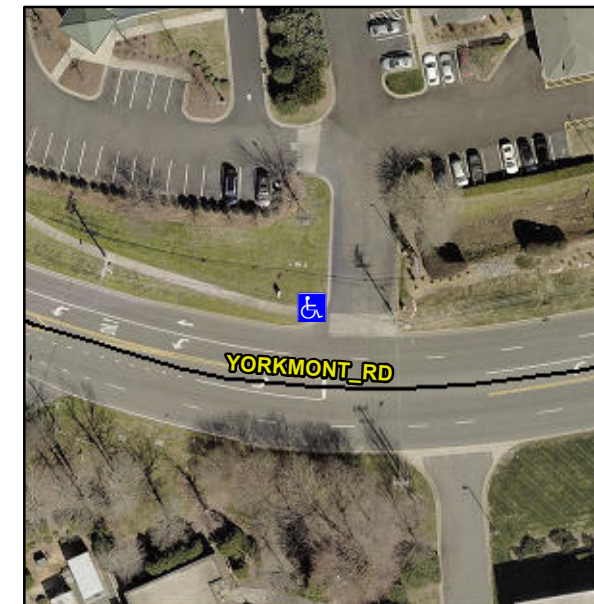
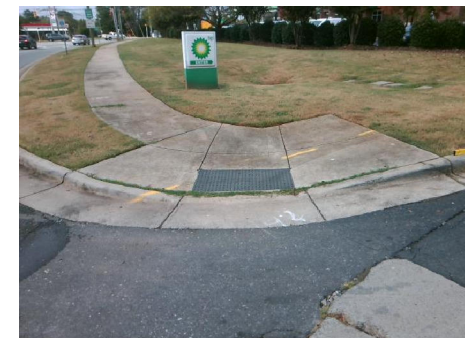
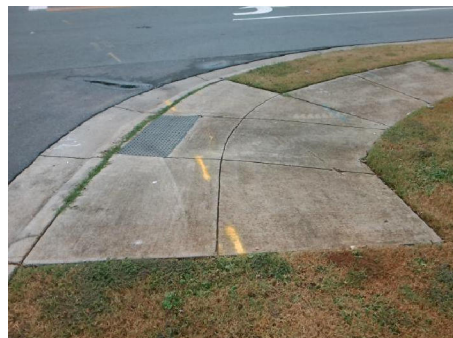
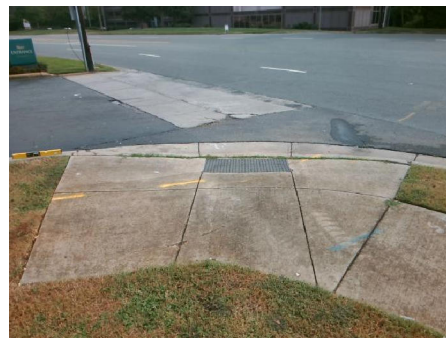
Compliance	Description	Data	Compliance	Description	Data
N/A	Ramp Length (in)	64.0	Yes	BlendTrans Slope (%)	4.0
Yes	Ramp Width (in)	48.0	Yes	BlendTrans XSlope (%)	0.3
N/A	Flare Type LT	Sloped	N/A	Flare Type RT	Sloped
N/A	Flare Slope LT (%)	2.3	N/A	Flare Slope RT (%)	7.5
N/A	Flare Traversable LT?	No	N/A	Flare Traversable RT?	No
Yes	Landing Length (in)	48.0	Yes	DWS Provided?	Yes
No	Landing Width (in)	46.0	Yes	DWS Contrast?	Yes
Yes	Landing Slope (%)	0.7	Yes	DWS Length (in)	24.5
Yes	Landing X Slope (%)	0.6	Yes	DWS Full Width?	Yes
N/A	Landing Curb? (Y/N)	No	No	DWS Offset (in)	2.5
N/A	Shared Landing?	No			
Yes	Gutter Ponding?	No	Yes	Gutter Slope (%)	0.9
Yes	Gutter Lip Ht (in)	0.0	Yes	Gutter X Slope (%)	1.0
N/A	Painted X Walk1?	No	N/A	Painted X Walk2?	No
	X Walk 1 Direction	To S		X Walk 2 Direction	To E
	X Walk 1 Width (in)	N/A		X Walk 2 Width (in)	N/A
	X Walk 1 Slope (%)	0.7		X Walk 2 Slope (%)	4.6
	X Walk 1 X Slope (%)	1.8		X Walk 2 X Slope (%)	2.2

N/A	Ramp inside XWalk1?	N/A	N/A	Ramp inside XWalk2?	N/A
	Road Slope (%)	1.6		Clear Space?	Yes
	Road X Slope (%)	0.2	N/A	Clear Space to XWalk (in)	N/A
Yes	Any Obstructions?	No	Yes	Storm Grate/Utility Hazard?	No
	Obstruction Type			Storm Grate/Utility Type	
		N/A			N/A
			Yes	Surface Condition? (G/P)	Good
			Yes	Curb Slope (%)	0.3

Possible Solutions:

**Remove & Replace Curb Ramp With Two New Directional Ramps or Equivalent.**

**R304.2.1, R305.2**

Total Cost: \$ 3200.00
