# Access Compliance Report

## Public Rights-of-Way

### (Curb Ramps)

| Intersection ID: 45733 | Main Street: REDWOOD VALLEY LN | Cross Street: DALTREY LN | Location: SW |

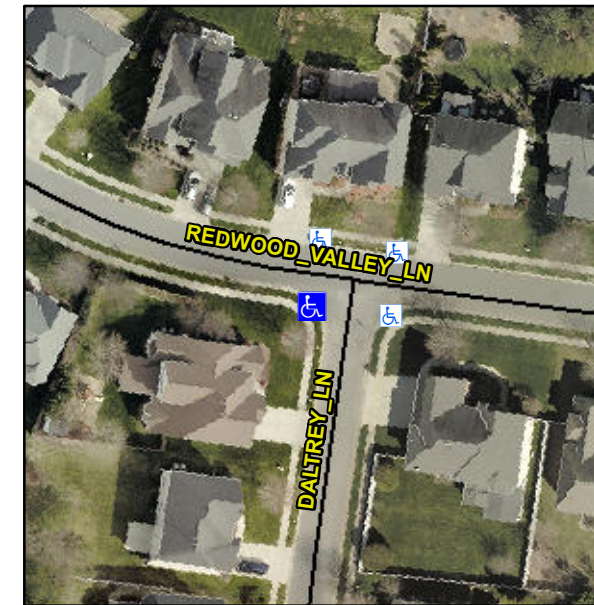
| ADA ID: 8E002FCC83F0 | Ramp Type: Perpendicular Diagonal | Initial Pass/Fail: Fail | Overall Compliance: No |
| | | Severity Score: 12.5 | |

**Not Found, R304.2.2**

| Compliance | Description | Data | Compliance | Description | Data |
|---|---|---|---|---|---|
| N/A | Ramp Length (in) | 48.0 | No | Ramp Slope (%) | 8.7 |
| Yes | Ramp Width (in) | 48.0 | Yes | Ramp XSlope (%) | 0.4 |

**Remove & Replace Curb Ramp With Two New Directional Ramps or Equivalent.**

Total Cost: \$ 3200.00
