# Access Compliance Report

## Public Rights-of-Way

### (Curb Ramps)

Intersection ID: 11265	Main Street: N_TRYON_ST	Cross Street: WADSWORTH_PL	Location: E
ADA ID: 8E04A81EA762	Ramp Type: Directional1	Initial Pass/Fail: Fail	Overall Compliance: No
		Severity Score: 12.5

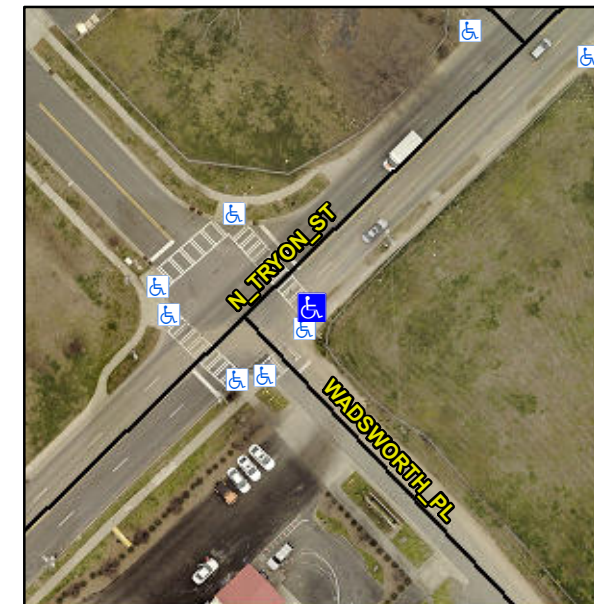
Compliance	Description	Data	Compliance	Description	Data
N/A	Ramp Length (in)	25.0	N/A	Grade Break?	N/A
Yes	Ramp Width (in)	58.0	N/A	Grade Break Slope (%)	0.0
No	Ramp Slope (%)	10.4	N/A	Grade Break XSlope (%)	0.0
Yes	Ramp XSlope (%)	0.4			
N/A	Flare Type LT	N/A	N/A	Flare Type RT	N/A
N/A	Flare Slope LT (%)	N/A	N/A	Flare Slope RT (%)	0.0
N/A	Flare Traversable LT?	N/A	N/A	Flare Traversable RT?	N/A
N/A	Landing Length (in)	0.0	N/A	DWS Provided?	N/A
N/A	Landing Width (in)	0.0	N/A	DWS Contrast?	N/A
N/A	Landing Slope (%)	0.0	N/A	DWS Length (in)	N/A
N/A	Landing X Slope (%)	0.0	N/A	DWS Full Width?	N/A
N/A	Landing Curb? (Y/N)	N/A	N/A	DWS Offset LT (in)	N/A
N/A	Shared Landing?	N/A	N/A	DWS Offset RT (in)	N/A
N/A	Gutter Ponding?	Yes	N/A	Gutter Slope (%)	N/A
N/A	Gutter Lip Ht (in)	0.0	N/A	Gutter X Slope (%)	N/A
N/A	Painted X Walk1?	Yes		Road Slope (%)	4.4
	X Walk 1 Direction	To NW		Road X Slope (%)	1.0
	X Walk 1 Width (in)	117.5		Clear Space?	N/A

X Walk 1 Slope (%)	4.4	N/A	Clear Space to XWalk (in)	N/A
	X Walk 1 X Slope (%)	1.0	N/A	Storm Grate/Utility Hazard?	N/A
N/A	Ramp inside XWalk1?	Yes		Storm Grate/Utility Type	
N/A	Any Obstructions?	N/A			N/A
	Obstruction Type		Yes	Surface Condition? (G/P)	Good
			N/A	Curb Slope (%)	N/A

**Remove & Replace Entire Ramp.**

**R304.2.2**

**\$ 1600.00**
