# Access Compliance Report

## Public Rights-of-Way

Intersection ID: 13820	Main Street: LAMAR_AV	Cross Street: PARK_DR	Location: N
ADA ID: 8E04E9ABE5E1	Ramp Type: Perpendicular	Initial Pass/Fail: Fail	Overall Compliance: No
			Severity Score: 26.25

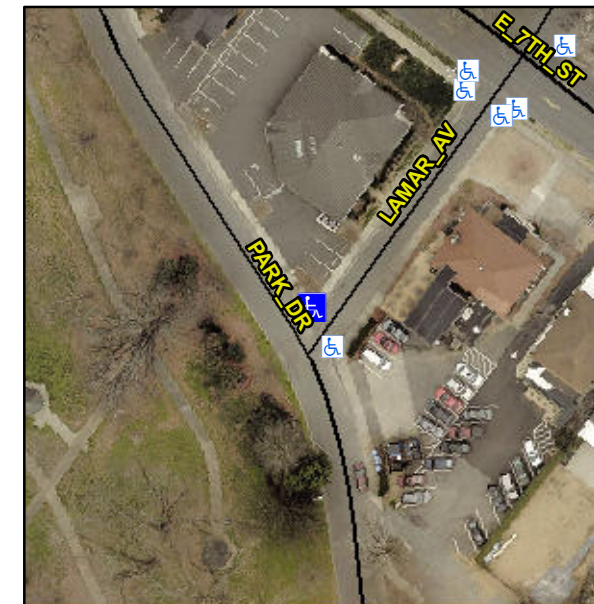
Compliance	Description	Data	Compliance	Description	Data
N/A	Ramp Length (in)	57.0	No	Ramp Slope (%)	12.7
Yes	Ramp Width (in)	48.0	No	Ramp XSlope (%)	3.1
N/A	Flare Type LT	N/A	N/A	Flare Type RT	N/A
N/A	Flare Slope LT (%)	N/A	N/A	Flare Slope RT (%)	N/A
N/A	Flare Traversable LT?	N/A	N/A	Flare Traversable RT?	N/A
N/A	Landing Length (in)	N/A	N/A	DWS Provided?	N/A
N/A	Landing Width (in)	N/A	N/A	DWS Contrast?	N/A
N/A	Landing Slope (%)	N/A	N/A	DWS Length (in)	N/A
N/A	Landing X Slope (%)	N/A	N/A	DWS Full Width?	N/A
N/A	Landing Curb? (Y/N)	N/A	N/A	DWS Offset (in)	N/A
N/A	Shared Landing?	N/A			
N/A	Gutter Ponding?	N/A	N/A	Gutter Slope (%)	N/A
N/A	Gutter Lip Ht (in)	2.0	N/A	Gutter X Slope (%)	N/A
N/A	Painted X Walk1?	No	N/A	Painted X Walk2?	N/A
	X Walk 1 Direction	To S		X Walk 2 Direction	N/A
N/A	X Walk 1 Width (in)	N/A	N/A	X Walk 2 Width (in)	N/A
	X Walk 1 Slope (%)	3.1		X Walk 2 Slope (%)	N/A
	X Walk 1 X Slope (%)	1.8		X Walk 2 X Slope (%)	N/A

N/A	Ramp inside XWalk1?	N/A	N/A	Ramp inside XWalk2?	N/A
	Road Slope (%)	N/A	N/A	Clear Space?	N/A
	Road X Slope (%)	N/A	N/A	Clear Space to XWalk (in)	N/A
N/A	Any Obstructions?	N/A	N/A	Storm Grate/Utility Hazard?	N/A
	Obstruction Type			Storm Grate/Utility Type	
		N/A			N/A
			Yes	Surface Condition? (G/P)	Good

**Remove & Replace Entire Ramp.**
