Access Compliance Report

Public Rights-of-Way

(Curb Ramps)

Intersection ID: N/A	Main Street: E_4TH_ST	Cross Street: S_CALDWELL_ST	Location: S
ADA ID: 8E084957DBC1	Ramp Type: Perpendicular	Initial Pass/Fail: Pass	Overall Compliance: No
Severity Score: 0			
Codes/Mitigation Info/Possible Solution		Field Measurements/Component Compliance

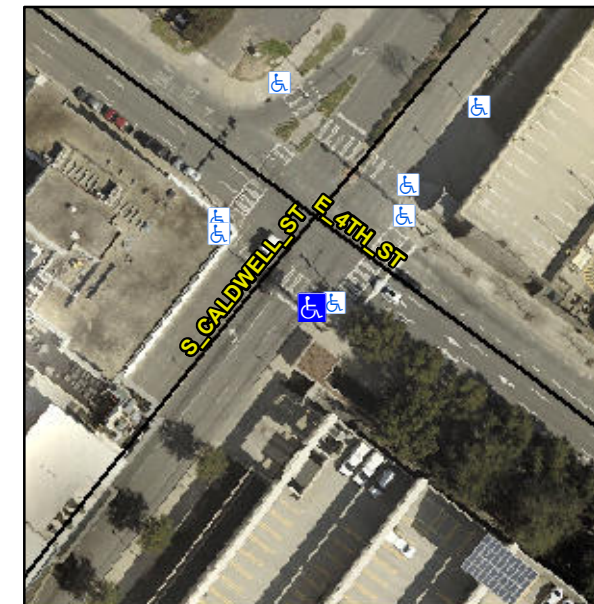
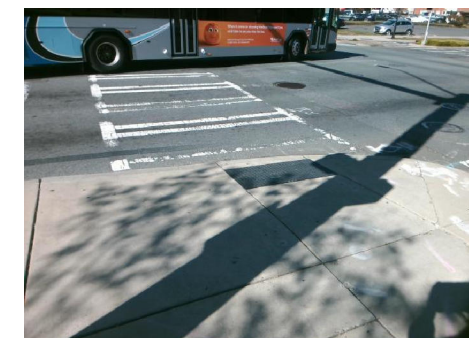
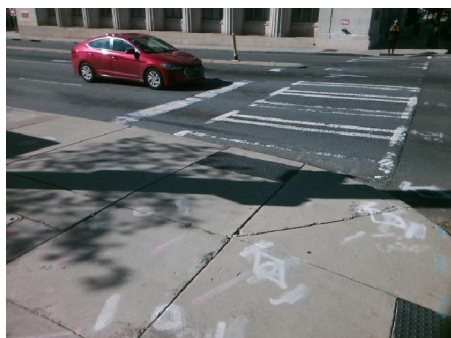
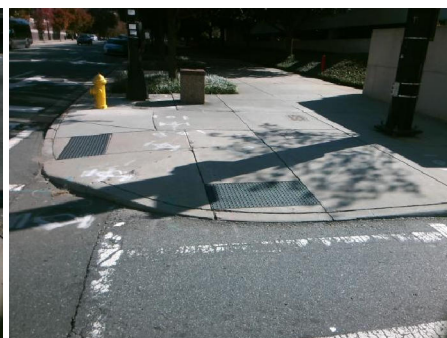
Compliance	Description	Data	Compliance	Description	Data
N/A	Ramp Length (in)	77.0	Yes	Ramp Slope (%)	5.9
Yes	Ramp Width (in)	49.0	Yes	Ramp XSlope (%)	0.6
N/A	Flare Type LT	Sloped	N/A	Flare Type RT	N/A
N/A	Flare Slope LT (%)	7.8	Yes	Flare Slope RT (%)	0.2
N/A	Flare Traversable LT?	Yes	N/A	Flare Traversable RT?	Yes
Yes	Landing Length (in)	48.0	Yes	DWS Provided?	Yes
Yes	Landing Width (in)	51.0	Yes	DWS Contrast?	Yes
Yes	Landing Slope (%)	1.0	Yes	DWS Length (in)	24.5
No	Landing X Slope (%)	2.9	Yes	DWS Full Width?	Yes
N/A	Landing Curb? (Y/N)	No	No	DWS Offset (in)	6.5
N/A	Shared Landing?	Yes			
Yes	Gutter Ponding?	No	Yes	Gutter Slope (%)	3.4
Yes	Gutter Lip Ht (in)	0.0	Yes	Gutter X Slope (%)	1.6
N/A	Painted X Walk1?	Yes	N/A	Painted X Walk2?	N/A
	X Walk 1 Direction	To NW		X Walk 2 Direction	N/A
N/A	X Walk 1 Width (in)	120.0	N/A	X Walk 2 Width (in)	N/A
	X Walk 1 Slope (%)	0.4		X Walk 2 Slope (%)	N/A
	X Walk 1 X Slope (%)	1.7		X Walk 2 X Slope (%)	N/A

Yes	Ramp inside XWalk1?	Yes	N/A	Ramp inside XWalk2?	N/A
	Road Slope (%)	N/A	N/A	Clear Space?	Yes
	Road X Slope (%)	N/A	N/A	Clear Space to XWalk (in)	N/A
Yes	Any Obstructions?	No	Yes	Storm Grate/Utility Hazard?	No
	Obstruction Type			Storm Grate/Utility Type	
		N/A			N/A
			Yes	Surface Condition? (G/P)	Good

Possible Solutions:

Remove & Replace Entire Ramp.

R304.5.3, R305.2
