Access Compliance Report

Public Rights-of-Way

(Curb Ramps)

Intersection ID: 29983	Main Street: REAMES_RD	Cross Street: SILVER_GARDEN_LN	Location: NE
ADA ID: 8E10CB284277	Ramp Type: Perpendicular	Initial Pass/Fail: Fail	Overall Compliance: No
			Severity Score: 13.75

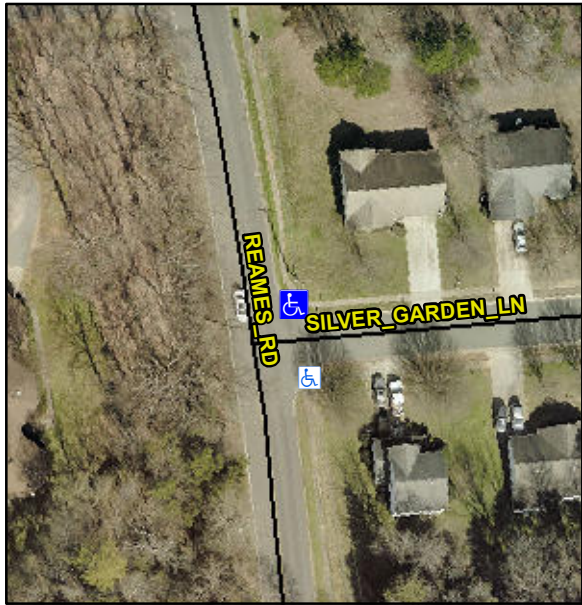
Possible Solutions:		Compliance	Description	Data	Compliance	Description	Data
	Remove & Replace Entire Ramp.		N/A	Ramp Length (in)	100.0	No	Ramp Slope (%)	9.6
			Yes	Ramp Width (in)	48.0	No	Ramp XSlope (%)	2.8
			N/A	Flare Type LT	N/A	N/A	Flare Type RT	N/A
			N/A	Flare Slope LT (%)	N/A	N/A	Flare Slope RT (%)	N/A
			N/A	Flare Traversable LT?	N/A	N/A	Flare Traversable RT?	N/A
			N/A	Landing Length (in)	N/A	N/A	DWS Provided?	N/A
			N/A	Landing Width (in)	N/A	N/A	DWS Contrast?	N/A
			N/A	Landing Slope (%)	N/A	N/A	DWS Length (in)	N/A
			N/A	Landing X Slope (%)	N/A	N/A	DWS Full Width?	N/A
Surveyor Notes:		N/A	N/A	Landing Curb? (Y/N)	N/A	N/A	DWS Offset (in)	N/A
PROW/ADA:		Not Found, R304.2.2, R304.5.3	N/A	Shared Landing?	N/A	N/A	Gutter Slope (%)	N/A
			N/A	Gutter Ponding?	N/A	N/A	Gutter X Slope (%)	N/A
			N/A	Gutter Lip Ht (in)	N/A	N/A	Gutter X Slope (%)	N/A

N/A	Painted X Walk1?	No	N/A	Painted X Walk2?	N/A
				X Walk 1 Direction	To S		X Walk 2 Direction	N/A
			N/A	X Walk 1 Width (in)	N/A	N/A	X Walk 2 Width (in)	N/A
				X Walk 1 Slope (%)	2.7		X Walk 2 Slope (%)	N/A
				X Walk 1 X Slope (%)	5.5		X Walk 2 X Slope (%)	N/A
			N/A	Ramp inside XWalk1?	N/A	N/A	Ramp inside XWalk2?	N/A
				Road Slope (%)	N/A	N/A	Clear Space?	N/A
				Road X Slope (%)	N/A	N/A	Clear Space to XWalk (in)	N/A
			N/A	Any Obstructions?	N/A	N/A	Storm Grate/Utility Hazard?	N/A
				Obstruction Type			Storm Grate/Utility Type	
					N/A			N/A
						Yes	Surface Condition? (G/P)	Good
					</
