# Access Compliance Report

## Public Rights-of-Way

### (Curb Ramps)

| Intersection ID: 10016404 | Main Street: MILHAVEN_LN | Cross Street: N/A | Location: W |

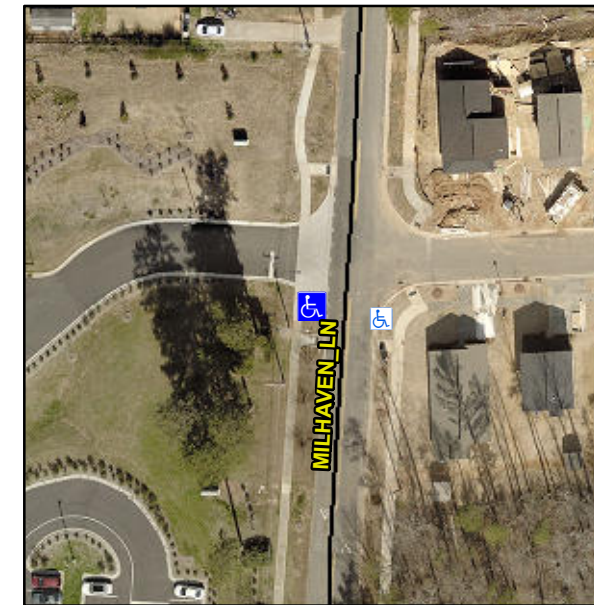
**NO CURB**

**Not Found, R304.2.2-Perp, R304.3.2-  
Para, R305.1.4, R305.2, R302.7,  
R302.7.2, R304.5.4**

| Compliance | Description | Data | Compliance | Description | Data |
|---|---|---|---|---|---|
| No | Landing Slope (%) | 3.4 | Yes | DWS Length (in) | 24.5 |
| Yes | Landing X Slope (%) | 0.6 | No | DWS Full Width? | No |
| No | Gutter Ponding? | Yes | No | Gutter Slope (%) | 5.5 |
| No | Gutter Lip Ht (in) | 0.3 | Yes | Gutter X Slope (%) | 0.3 |

Possible Solutions:

**Remove & Replace Entire Ramp.  
Remove & Replace Gutter.**
