| Intersection ID: 27478 | | Main Street: BALLANTYNE MEADOWS DR | | Cross Street: BLUE CEDAR LN | | Location: | | NE | | | |
| ADA ID: 8E265AE2DC2C | | Ramp Type: Perpendicular Diagonal | | Initial Pass/Fail: Fail | | Overall Compliance: No | | Severity Score: 26.25 | | | |

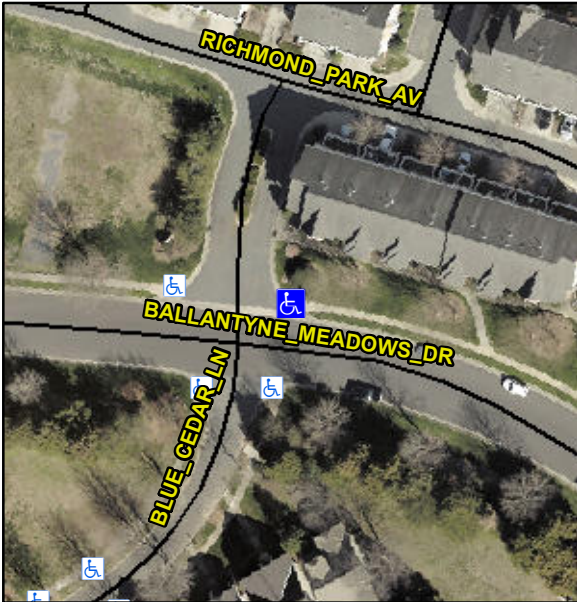
| PROW/ADA: | | | | R304.2.2, R304.5.3 | | N/A | | Flare Slope LT (%) | | N/A | |

| | | | | Remove & Replace Curb Ramp With Two New Directional Ramps or Equivalent. | | N/A | | Ramp Length (in) | | 45.0 | |
