# Access Compliance Report

## Public Rights-of-Way

### (Curb Ramps)

Intersection ID: 10806	Main Street: MORSON_ST	Cross Street: STATE_ST	Location: SW
ADA ID: 8E3288701D87	Ramp Type: Directional2	Initial Pass/Fail: Fail	Overall Compliance: No
Severity Score: 21.25			
Codes/Mitigation Info/Possible Solution		Field Measurements/Component Compliance

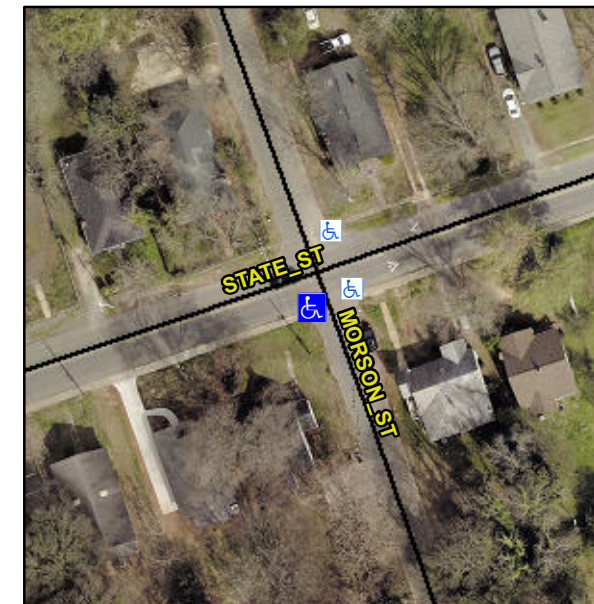
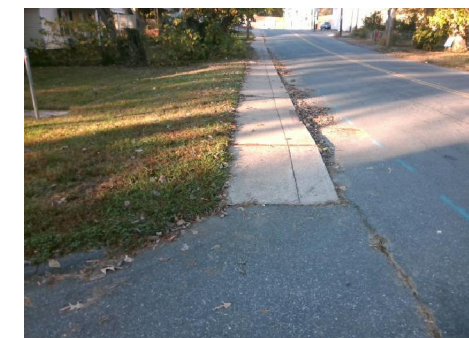
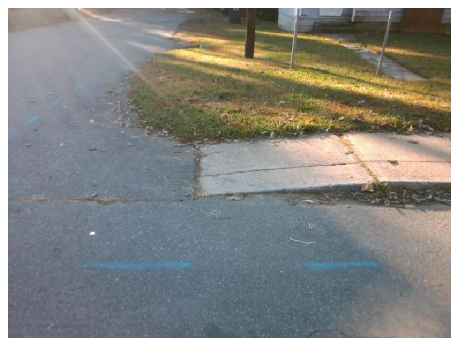
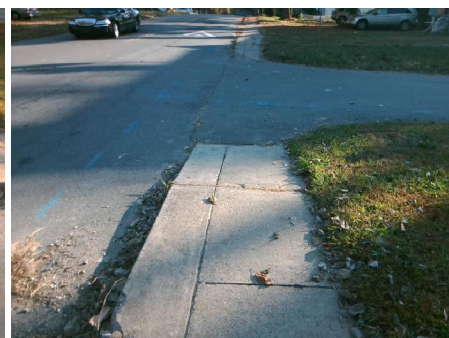
**NO CURB**

Compliance	Description	Data	Compliance	Description	Data
N/A	Ramp Length (in)	63.0	N/A	Grade Break?	N/A
No	Ramp Width (in)	36.0	N/A	Grade Break Slope (%)	0.0
No	Ramp Slope (%)	8.7	N/A	Grade Break XSlope (%)	0.0
Yes	Ramp XSlope (%)	1.8			
N/A	Flare Type LT	N/A	N/A	Flare Type RT	N/A
N/A	Flare Slope LT (%)	N/A	N/A	Flare Slope RT (%)	0.0
N/A	Flare Traversable LT?	N/A	N/A	Flare Traversable RT?	N/A
N/A	Landing Length (in)	0.0	N/A	DWS Provided?	N/A
N/A	Landing Width (in)	0.0	N/A	DWS Contrast?	N/A
N/A	Landing Slope (%)	0.0	N/A	DWS Length (in)	N/A
N/A	Landing X Slope (%)	0.0	N/A	DWS Full Width?	N/A
N/A	Landing Curb? (Y/N)	N/A	N/A	DWS Offset LT (in)	N/A
N/A	Shared Landing?	N/A	N/A	DWS Offset RT (in)	N/A
N/A	Gutter Ponding?	0.0	N/A	Gutter Slope (%)	N/A
N/A	Gutter Lip Ht (in)	0.0	N/A	Gutter X Slope (%)	N/A
N/A	Painted X Walk1?	No		Road Slope (%)	5.0
	X Walk 1 Direction	To E		Road X Slope (%)	5.4
	X Walk 1 Width (in)	N/A		Clear Space?	N/A

X Walk 1 Slope (%)	5.0	N/A	Clear Space to XWalk (in)	N/A
	X Walk 1 X Slope (%)	5.4	N/A	Storm Grate/Utility Hazard?	N/A
N/A	Ramp inside XWalk1?	N/A		Storm Grate/Utility Type	
N/A	Any Obstructions?	N/A			N/A
	Obstruction Type		Yes	Surface Condition? (G/P)	Good
			N/A	Curb Slope (%)	N/A

**Remove & Replace Entire Ramp.**
