# Access Compliance Report

## Public Rights-of-Way

### (Curb Ramps)

| Intersection ID: 46912 | Main Street: PARKERS_CROSSING_DR | Cross Street: ANGELA_MARIE_CT | Location: NW |

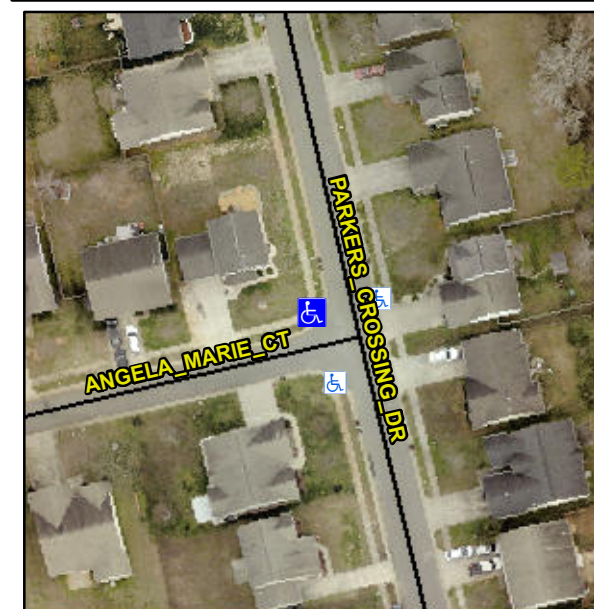
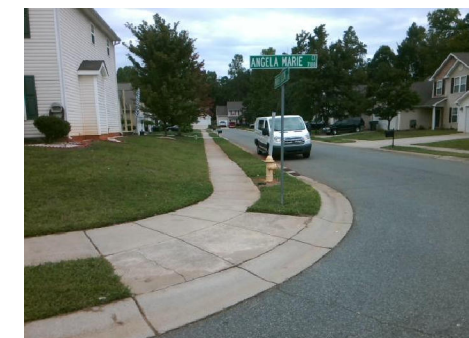
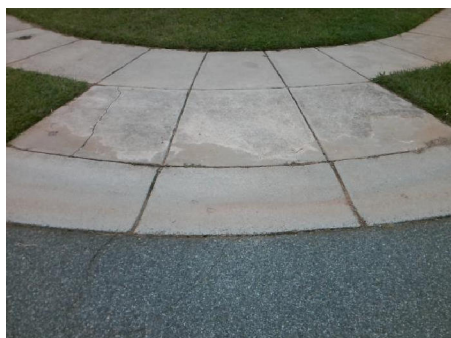
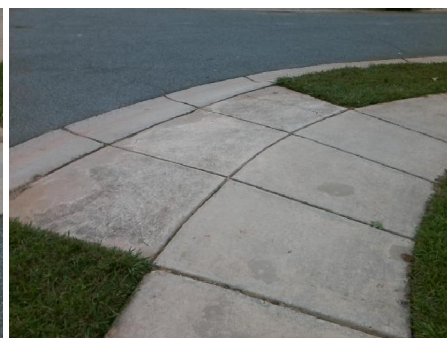
| ADA ID: 8E33F319A083 | Ramp Type: Perpendicular Diagonal | Initial Pass/Fail: Fail | Overall Compliance: No |
| Severity Score: 21.25 | | | |

**Not Found, R304.5.1, R304.2.2**

| Compliance | Description | Data | Compliance | Description | Data |
|---|---|---|---|---|---|
| N/A | Ramp Length (in) | 47.5 | No | Ramp Slope (%) | 9.0 |
| No | Ramp Width (in) | 36.0 | Yes | Ramp XSlope (%) | 1.2 |

**Remove & Replace Curb Ramp With Two New Directional Ramps or Equivalent.**

Total Cost: \$ 3200.00
