# Access Compliance Report

## Public Rights-of-Way

### (Curb Ramps)

| Intersection ID: N/A | Main Street: E_4TH_ST | Cross Street: S_COLLEGE_ST | Location: S |

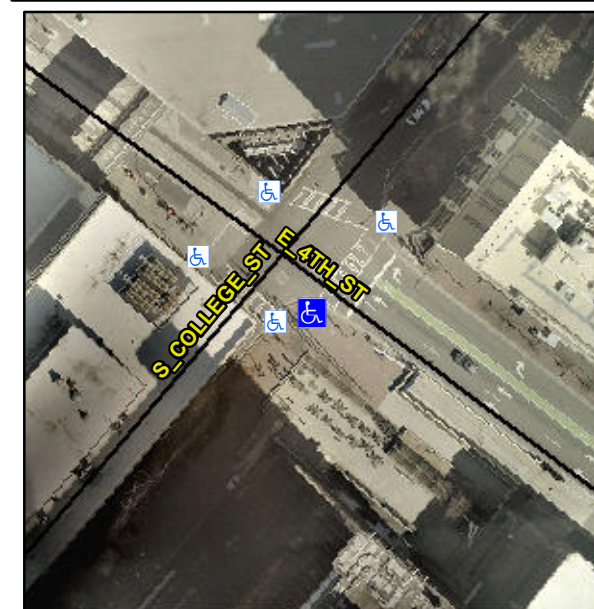
| ADA ID: 8E3B8FE16337 | Ramp Type: Perpendicular | Initial Pass/Fail: Fail | Overall Compliance: No |
| Severity Score: 12.5 | | | |

**R304.2.2**

| Compliance | Description | Data | Compliance | Description | Data |
|---|---|---|---|---|---|
| N/A | Ramp Length (in) | 6.0 | No | Ramp Slope (%) | 9.8 |

**Remove & Replace Entire Ramp.**

**\$ 1850.00**
