Access Compliance Report

Public Rights-of-Way

(Curb Ramps)

Intersection ID: 22493	Main Street: SCARLET_OAK_LN	Cross Street: SHARON_VIEW_RD	Location: SW
ADA ID: 8E3F78DA2099	Ramp Type: Perpendicular Diagonal	Initial Pass/Fail: Fail	Overall Compliance: No
		Severity Score: 50

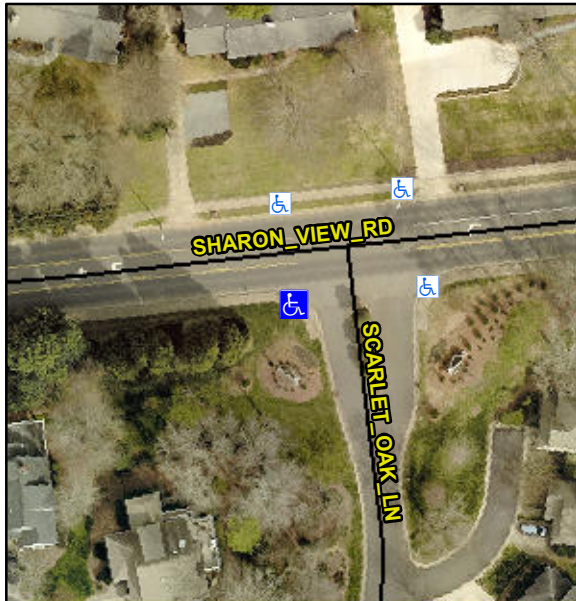
Not Found, R304.2.2, R304.5.3

Compliance	Description	Data	Compliance	Description	Data
N/A	Ramp Length (in)	59.0	No	Ramp Slope (%)	12.1
Yes	Ramp Width (in)	48.0	No	Ramp XSlope (%)	7.0
N/A	Flare Type LT	N/A	N/A	Flare Type RT	N/A
N/A	Flare Slope LT (%)	N/A	N/A	Flare Slope RT (%)	N/A
N/A	Flare Traversable LT?	N/A	N/A	Flare Traversable RT?	N/A
N/A	Landing Length (in)	N/A	N/A	DWS Provided?	N/A
N/A	Landing Width (in)	N/A	N/A	DWS Contrast?	N/A
N/A	Landing Slope (%)	N/A	N/A	DWS Length (in)	N/A
N/A	Landing X Slope (%)	N/A	N/A	DWS Full Width?	N/A
N/A	Landing Curb? (Y/N)	N/A	N/A	DWS Offset (in)	N/A
N/A	Shared Landing?	N/A			
N/A	Gutter Ponding?	N/A	N/A	Gutter Slope (%)	N/A
N/A	Gutter Lip Ht (in)	N/A	N/A	Gutter X Slope (%)	N/A
N/A	Painted X Walk1?	No	N/A	Painted X Walk2?	No
	X Walk 1 Direction	To E		X Walk 2 Direction	To N
N/A	X Walk 1 Width (in)	N/A	N/A	X Walk 2 Width (in)	N/A
	X Walk 1 Slope (%)	0.9		X Walk 2 Slope (%)	3.7
	X Walk 1 X Slope (%)	3.6		X Walk 2 X Slope (%)	1.9

N/A	Ramp inside XWalk1?	N/A	N/A	Ramp inside XWalk2?	N/A
	Road Slope (%)	3.3	N/A	Clear Space?	N/A
	Road X Slope (%)	2.4	N/A	Clear Space to XWalk (in)	N/A
N/A	Any Obstructions?	N/A	N/A	Storm Grate/Utility Hazard?	N/A
	Obstruction Type			Storm Grate/Utility Type	
		N/A			N/A
			Yes	Surface Condition? (G/P)	Good

Remove & Replace Curb Ramp With Two New Directional Ramps or Equivalent.
