Access Compliance Report

Public Rights-of-Way

(Curb Ramps)

Intersection ID: 4973	Main Street: MALLARD_CREEK_RD	Cross Street: W_W_T_HARRIS_BV	Location:	N
ADA ID: 8E5BCB9486CD	Ramp Type: Perpendicular	Initial Pass/Fail: Fail	Overall Compliance: No	Severity Score: 22.5

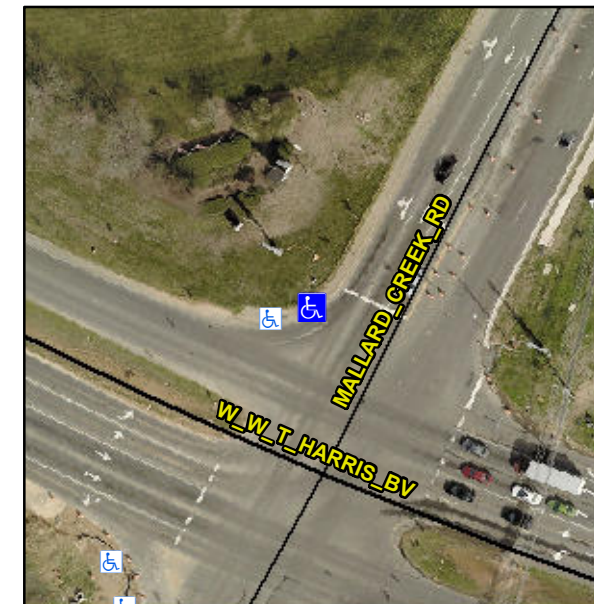
Not Found, R304.5.1, R304.2.2

Compliance	Description	Data	Compliance	Description	Data
N/A	Ramp Length (in)	63.0	No	Ramp Slope (%)	8.9
No	Ramp Width (in)	44.0	Yes	Ramp XSlope (%)	2.1
N/A	Flare Type LT	N/A	N/A	Flare Type RT	N/A
N/A	Flare Slope LT (%)	N/A	N/A	Flare Slope RT (%)	N/A
N/A	Flare Traversable LT?	N/A	N/A	Flare Traversable RT?	N/A
N/A	Landing Length (in)	N/A	N/A	DWS Provided?	N/A
N/A	Landing Width (in)	N/A	N/A	DWS Contrast?	N/A
N/A	Landing Slope (%)	N/A	N/A	DWS Length (in)	N/A
N/A	Landing X Slope (%)	N/A	N/A	DWS Full Width?	N/A
N/A	Landing Curb? (Y/N)	N/A	N/A	DWS Offset (in)	N/A
N/A	Shared Landing?	N/A			
N/A	Gutter Ponding?	N/A	N/A	Gutter Slope (%)	N/A
N/A	Gutter Lip Ht (in)	N/A	N/A	Gutter X Slope (%)	N/A
N/A	Painted X Walk1?	No	N/A	Painted X Walk2?	N/A
	X Walk 1 Direction	To E		X Walk 2 Direction	N/A
N/A	X Walk 1 Width (in)	N/A	N/A	X Walk 2 Width (in)	N/A
	X Walk 1 Slope (%)	1.0		X Walk 2 Slope (%)	N/A
	X Walk 1 X Slope (%)	2.8		X Walk 2 X Slope (%)	N/A

N/A	Ramp inside XWalk1?	N/A	N/A	Ramp inside XWalk2?	N/A
	Road Slope (%)	N/A	N/A	Clear Space?	N/A
	Road X Slope (%)	N/A	N/A	Clear Space to XWalk (in)	N/A
N/A	Any Obstructions?	N/A	N/A	Storm Grate/Utility Hazard?	N/A
	Obstruction Type			Storm Grate/Utility Type	
		N/A			N/A
			Yes	Surface Condition? (G/P)	Good

Remove & Replace Entire Ramp.
