Access Compliance Report

Public Rights-of-Way

(Curb Ramps)

Intersection ID: 50580	Main Street: LONGSTRAW_RD	Cross Street: PAPER_TREE_RD	Location: SE
ADA ID: 8E61D0984C7E	Ramp Type: Perpendicular	Initial Pass/Fail: Fail	Overall Compliance: No
			Severity Score: 21.25

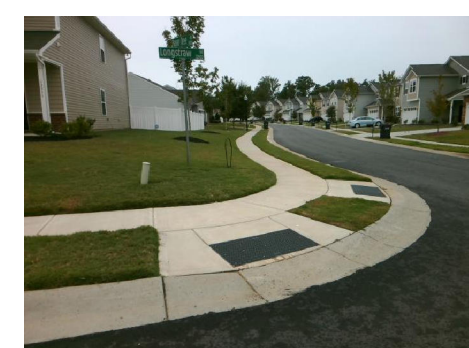
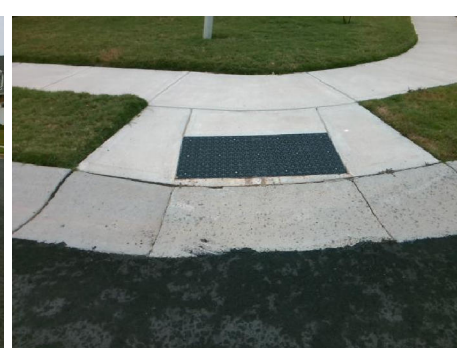
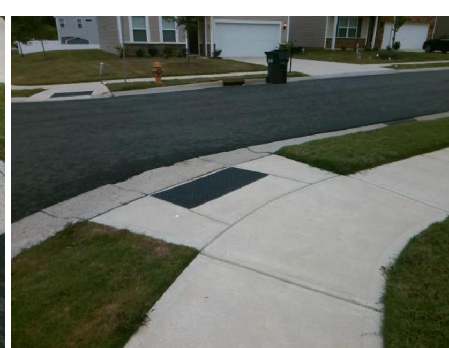
Possible Solutions:		Compliance	Description	Data	Compliance	Description	Data
	Remove & Replace Entire Ramp.		N/A	Ramp Length (in)	47.5	No	Ramp Slope (%)	10.0
			No	Ramp Width (in)	46.0	Yes	Ramp XSlope (%)	0.4
			N/A	Flare Type LT	N/A	N/A	Flare Type RT	N/A
			N/A	Flare Slope LT (%)	N/A	N/A	Flare Slope RT (%)	N/A
			N/A	Flare Traversable LT?	N/A	N/A	Flare Traversable RT?	N/A
			N/A	Landing Length (in)	N/A	N/A	DWS Provided?	N/A
			N/A	Landing Width (in)	N/A	N/A	DWS Contrast?	N/A
			N/A	Landing Slope (%)	N/A	N/A	DWS Length (in)	N/A
			N/A	Landing X Slope (%)	N/A	N/A	DWS Full Width?	N/A
Surveyor Notes:		N/A	N/A	Landing Curb? (Y/N)	N/A	N/A	DWS Offset (in)	N/A
PROW/ADA:		Not Found, R304.5.1, R304.2.2	N/A	Shared Landing?	N/A			
			N/A	Gutter Ponding?	N/A	N/A	Gutter Slope (%)	N/A
			N/A	Gutter Lip Ht (in)	N/A	N/A	Gutter X Slope (%)	N/A

N/A	Painted X Walk1?	No	N/A	Painted X Walk2?	N/A
				X Walk 1 Direction	To N		X Walk 2 Direction	N/A
			N/A	X Walk 1 Width (in)	N/A	N/A	X Walk 2 Width (in)	N/A
				X Walk 1 Slope (%)	1.8		X Walk 2 Slope (%)	N/A
				X Walk 1 X Slope (%)	1.4		X Walk 2 X Slope (%)	N/A
			N/A	Ramp inside XWalk1?	N/A	N/A	Ramp inside XWalk2?	N/A
				Road Slope (%)	N/A	N/A	Clear Space?	N/A
				Road X Slope (%)	N/A	N/A	Clear Space to XWalk (in)	N/A
			N/A	Any Obstructions?	N/A	N/A	Storm Grate/Utility Hazard?	N/A
				Obstruction Type			Storm Grate/Utility Type	
					N/A			N/A
						Yes	Surface Condition? (G/P)	Good
Total Cost:		\$ 1850.00
