Access Compliance Report

Public Rights-of-Way

(Curb Ramps)

Intersection ID: 50610	Main Street: GOLDEN_WOOD_LN	Cross Street: DOWNY_BIRCH_RD	Location: SE
ADA ID: 8E6488A4E5CA	Ramp Type: Perpendicular	Initial Pass/Fail: Pass	Overall Compliance: No
Severity Score: 0.25			
Codes/Mitigation Info/Possible Solution		Field Measurements/Component Compliance

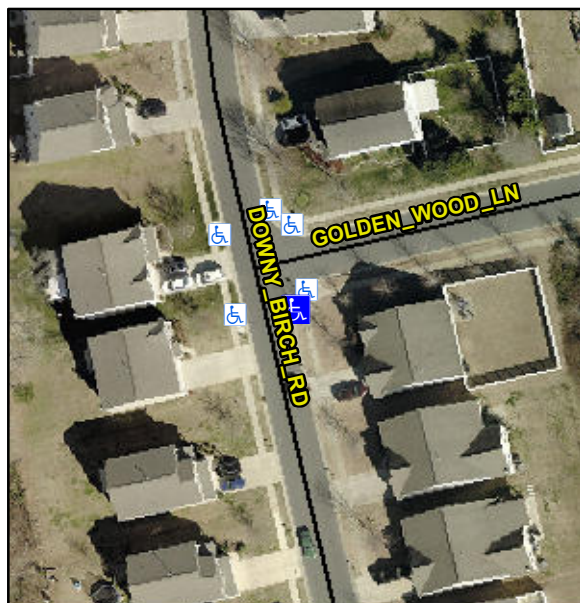
Compliance	Description	Data	Compliance	Description	Data
N/A	Ramp Length (in)	46.0	Yes	Ramp Slope (%)	6.9
Yes	Ramp Width (in)	48.0	Yes	Ramp XSlope (%)	2.1
N/A	Flare Type LT	Sloped	N/A	Flare Type RT	N/A
N/A	Flare Slope LT (%)	2.2	N/A	Flare Slope RT (%)	6.8
N/A	Flare Traversable LT?	No	N/A	Flare Traversable RT?	No
Yes	Landing Length (in)	48.0	Yes	DWS Provided?	Yes
Yes	Landing Width (in)	84.0	Yes	DWS Contrast?	Yes
No	Landing Slope (%)	3.7	Yes	DWS Length (in)	24.5
No	Landing X Slope (%)	2.4	Yes	DWS Full Width?	Yes
N/A	Landing Curb? (Y/N)	No	No	DWS Offset (in)	5.0
N/A	Shared Landing?	No			
Yes	Gutter Ponding?	No	Yes	Gutter Slope (%)	1.6
Yes	Gutter Lip Ht (in)	0.0	Yes	Gutter X Slope (%)	0.4
N/A	Painted X Walk1?	No	N/A	Painted X Walk2?	N/A
	X Walk 1 Direction	To W		X Walk 2 Direction	N/A
N/A	X Walk 1 Width (in)	N/A	N/A	X Walk 2 Width (in)	N/A
	X Walk 1 Slope (%)	0.8		X Walk 2 Slope (%)	N/A
	X Walk 1 X Slope (%)	2.1		X Walk 2 X Slope (%)	N/A

N/A	Ramp inside XWalk1?	N/A	N/A	Ramp inside XWalk2?	N/A
	Road Slope (%)	N/A	N/A	Clear Space?	Yes
	Road X Slope (%)	N/A	N/A	Clear Space to XWalk (in)	N/A
Yes	Any Obstructions?	No	Yes	Storm Grate/Utility Hazard?	No
	Obstruction Type			Storm Grate/Utility Type	
		N/A			N/A
			Yes	Surface Condition? (G/P)	Good

Remove & Replace Entire Ramp.
