## **Access Compliance Report Public Rights-of-Way** (Curb Ramps)

Intersection ID: 10014838 Main Street: THE PLAZA Cross Street: N/A SE Location:

Initial Pass/Fail: Pass **Overall Compliance: No** 0 ADA ID: 8E6DF781018B Ramp Type: Combination2Diag **Severity Score:**

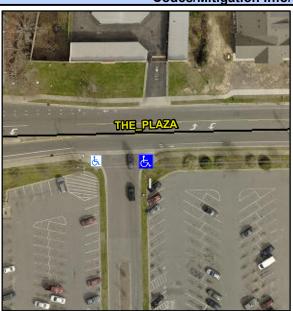
Street 1 Name Stop Condition-Street 1 Street 2 Name Stop Condition-Street 2 Possible Solutions: Remove & Replace Curb Ramp With Two New Directional Ramps or Equivalent. Remove & Replace Gutter. Surveyor Notes: N/A PROW/ADA: Not Found, R304.2.1, R304.5.3
