Access Compliance Report Public Rights-of-Way (Curb Ramps)

Intersection ID: 20136 Main Street: CLOSEBURN RD Cross Street: PARK_RD Location: NE ADA ID: 8E6FD0F27AAD Ramp Type: Perpendicular Diagonal Initial Pass/Fail: Fail **Overall Compliance: No** Severity Score: 13.75

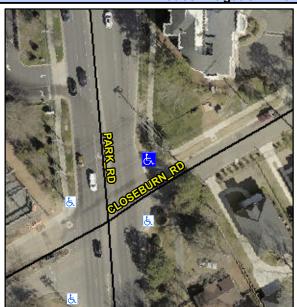
Field Measurements/Component Compliance					
Compliance Description		Data	Compliance Description		Data
N/A	Ramp Length (in)	73.0	No	Ramp Slope (%)	8.9
Yes	Ramp Width (in)	48.0	No	Ramp XSlope (%)	2.5
N/A	Flare Type LT	N/A	N/A	Flare Type RT	N/A
N/A	Flare Slope LT (%)	N/A	N/A	Flare Slope RT (%)	N/A
N/A	Flare Traversable LT?	N/A	N/A	Flare Traversable RT?	N/A
N/A	Landing Length (in)	N/A	N/A	DWS Provided?	N/A
N/A	Landing Width (in)	N/A	N/A	DWS Contrast?	N/A
N/A	Landing Slope (%)	N/A	N/A	DWS Length (in)	N/A
N/A	Landing X Slope (%)	N/A	N/A	DWS Full Width?	N/A
N/A	Landing Curb? (Y/N)	N/A	N/A	DWS Offset (in)	N/A
N/A	Shared Landing?	N/A			
N/A	Gutter Ponding?	N/A	N/A	Gutter Slope (%)	N/A
N/A	Gutter Lip Ht (in)	N/A	N/A	Gutter X Slope (%)	N/A
N/A	Painted X Walk1?	No	N/A	Painted X Walk2?	No
	X Walk 1 Direction	To SW		X Walk 2 Direction	To S
N/A	X Walk 1 Width (in)	N/A	N/A	X Walk 2 Width (in)	N/A
	X Walk 1 Slope (%)	3.3		X Walk 2 Slope (%)	2.4

X Walk 1 X Slope (%)	0.0		X Walk 2 X Slope (%)	5.2
N/A	Ramp inside XWalk1?	N/A	N/A	Ramp inside XWalk2?	N/A
	Road Slope (%)	1.4	N/A	Clear Space?	N/A
	Road X Slope (%)	1.3	N/A	Clear Space to XWalk (in)	N/A
N/A	Any Obstructions?	N/A	N/A	Storm Grate/Utility Hazard?	N/A
	Obstruction Type			Storm Grate/Utility Type	
		N/A			N/A
			Yes	Surface Condition? (G/P)	Good
Aldrew .	u dide.

Possible Solutions: Remove & Replace Curb Ramp With Two New Directional Ramps or Equivalent. Surveyor Notes: N/A PROW/ADA:
