# Access Compliance Report

## Public Rights-of-Way

### (Curb Ramps)

| Intersection ID: N/A | Main Street: E_JOHN_BELK_RA | Cross Street: E_STONEWALL_ST | Location: E |

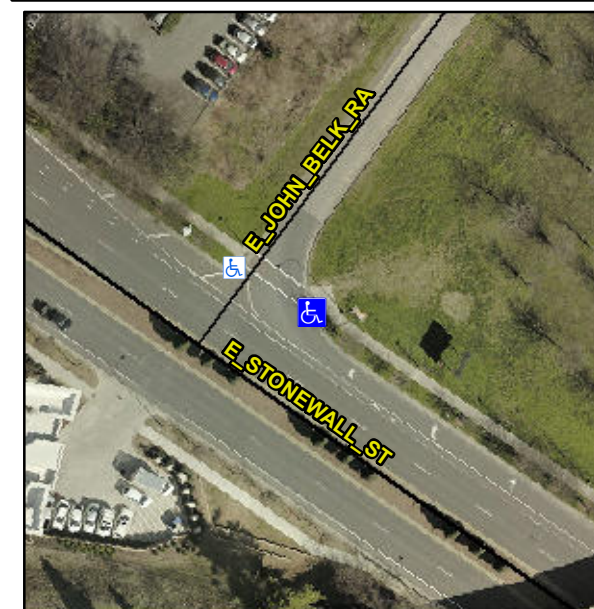
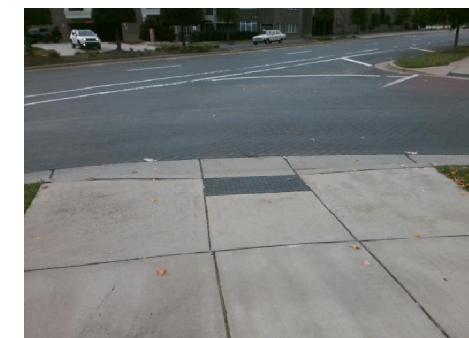
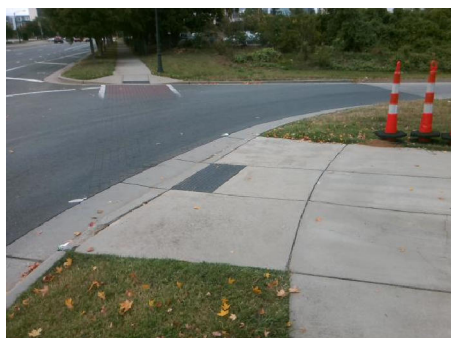
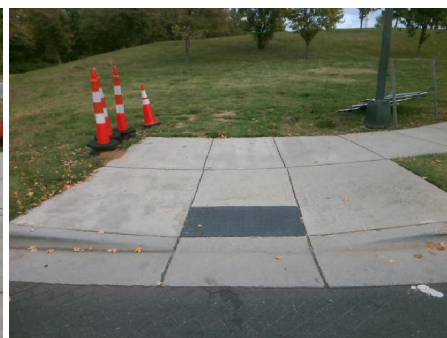
**Not Found, R304.5.3, R304.2.1, R304.2.2-Perp, R304.3.2-Para, R304.5.4**

| Compliance | Description | Data | Compliance | Description | Data |
|---|---|---|---|---|---|
| N/A | Ramp Length (in) | 71.0 | Yes | Ramp Slope (%) | 7.0 |
| Yes | Ramp Width (in) | 48.0 | No | Ramp XSlope (%) | 3.8 |
| No | Landing Width (in) | 44.5 | Yes | DWS Contrast? | Yes |
| No | Landing Slope (%) | 3.9 | Yes | DWS Length (in) | 24.0 |
| Yes | Gutter Ponding? | No | No | Gutter Slope (%) | 5.7 |
| Yes | Gutter Lip Ht (in) | 0.0 | No | Gutter X Slope (%) | 2.3 |

**Remove & Replace Curb Ramp With Two New Directional Ramps or Equivalent. Remove & Replace Gutter.**
