# Access Compliance Report

## Public Rights-of-Way

### (Curb Ramps)

Intersection ID: 24214	Main Street: HENSEY'S_WY	Cross Street: BEVERLY_CREST_BV	Location: W
ADA ID: 8E772869F556	Ramp Type: Perpendicular	Initial Pass/Fail: Fail	Overall Compliance: No
Severity Score: 12.5			
Codes/Mitigation Info/Possible Solution		Field Measurements/Component Compliance

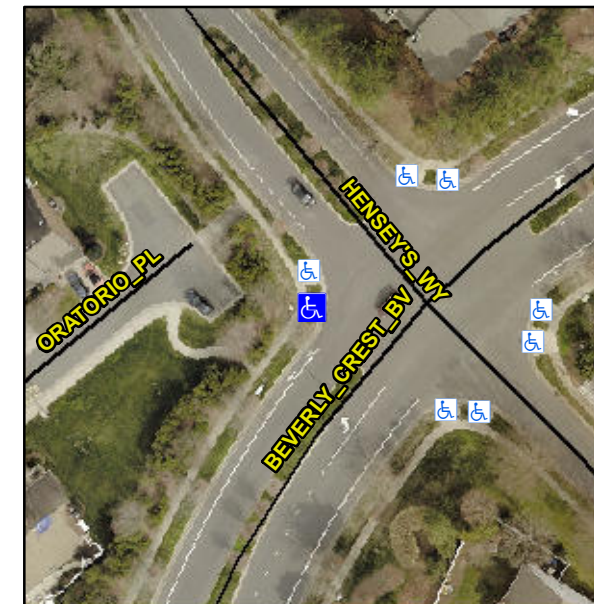
Compliance	Description	Data	Compliance	Description	Data
N/A	Ramp Length (in)	96.0	No	Ramp Slope (%)	9.0
Yes	Ramp Width (in)	66.0	Yes	Ramp XSlope (%)	1.2
N/A	Flare Type LT	N/A	N/A	Flare Type RT	N/A
N/A	Flare Slope LT (%)	N/A	N/A	Flare Slope RT (%)	N/A
N/A	Flare Traversable LT?	N/A	N/A	Flare Traversable RT?	N/A
N/A	Landing Length (in)	N/A	N/A	DWS Provided?	N/A
N/A	Landing Width (in)	N/A	N/A	DWS Contrast?	N/A
N/A	Landing Slope (%)	N/A	N/A	DWS Length (in)	N/A
N/A	Landing X Slope (%)	N/A	N/A	DWS Full Width?	N/A
N/A	Landing Curb? (Y/N)	N/A	N/A	DWS Offset (in)	N/A
N/A	Shared Landing?	N/A			
N/A	Gutter Ponding?	N/A	N/A	Gutter Slope (%)	N/A
N/A	Gutter Lip Ht (in)	N/A	N/A	Gutter X Slope (%)	N/A
N/A	Painted X Walk1?	No	N/A	Painted X Walk2?	N/A
	X Walk 1 Direction	To SE		X Walk 2 Direction	N/A
N/A	X Walk 1 Width (in)	N/A	N/A	X Walk 2 Width (in)	N/A
	X Walk 1 Slope (%)	1.6		X Walk 2 Slope (%)	N/A
	X Walk 1 X Slope (%)	0.2		X Walk 2 X Slope (%)	N/A

N/A	Ramp inside XWalk1?	N/A	N/A	Ramp inside XWalk2?	N/A
	Road Slope (%)	N/A	N/A	Clear Space?	N/A
	Road X Slope (%)	N/A	N/A	Clear Space to XWalk (in)	N/A
N/A	Any Obstructions?	N/A	N/A	Storm Grate/Utility Hazard?	N/A
	Obstruction Type			Storm Grate/Utility Type	
		N/A			N/A
		Yes		Surface Condition? (G/P)	Good

**Remove & Replace Entire Ramp.**
