# Access Compliance Report

## Public Rights-of-Way

| Intersection ID: 12577 | Main Street: SEIGLE_AV | Cross Street: GREEN_TRAIL_LN | Location: W |
| ADA ID: 8E7EE1DA41C8 | Ramp Type: Directional1 | Initial Pass/Fail: Fail | Overall Compliance: No |

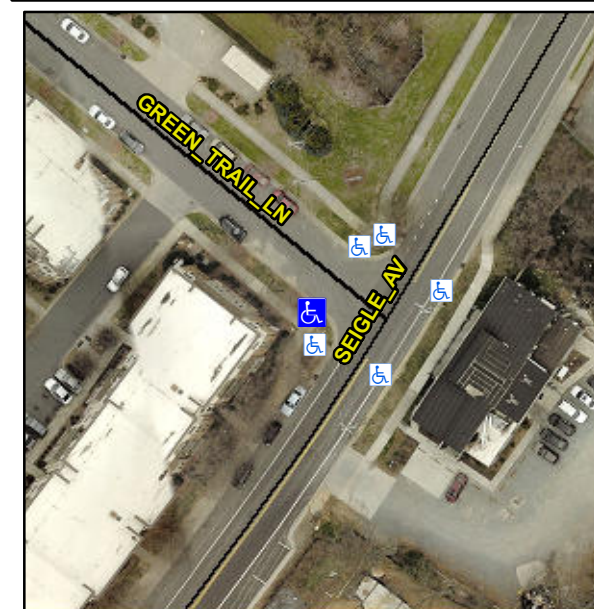
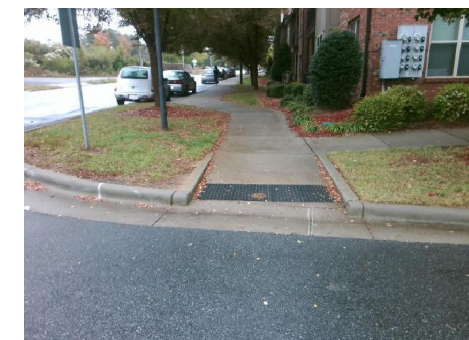
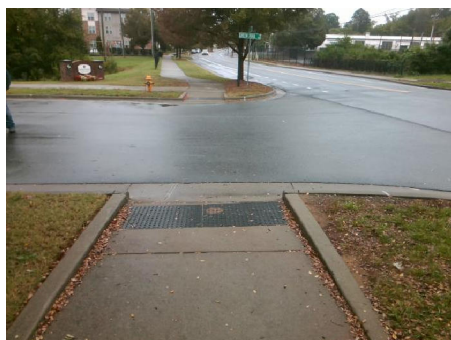
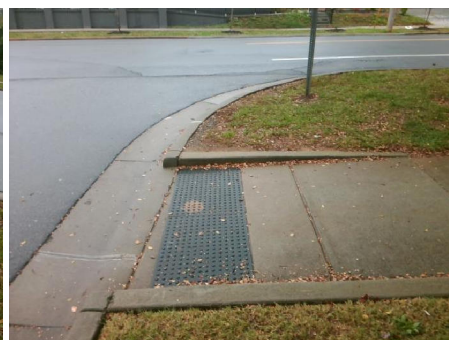
| Severity Score: 1.25 | | | |

**R304.5.3**

| Compliance | Description | Data | Compliance | Description | Data |
|---|---|---|---|---|---|
| No | Ramp XSlope (%) | 3.1 | | | |

**Remove & Replace Entire Ramp.**

\$ 1600.00
