# Access Compliance Report

## Public Rights-of-Way

### (Curb Ramps)

Intersection ID: 11306	Main Street: W_9TH_ST	Cross Street: N_SMITH_ST	Location: W
ADA ID: 8E82CE3810AA	Ramp Type: BlendTrans1	Initial Pass/Fail: Fail	Overall Compliance: No
		Severity Score: 8.75	
Codes/Mitigation Info/Possible Solution		Field Measurements/Component Compliance

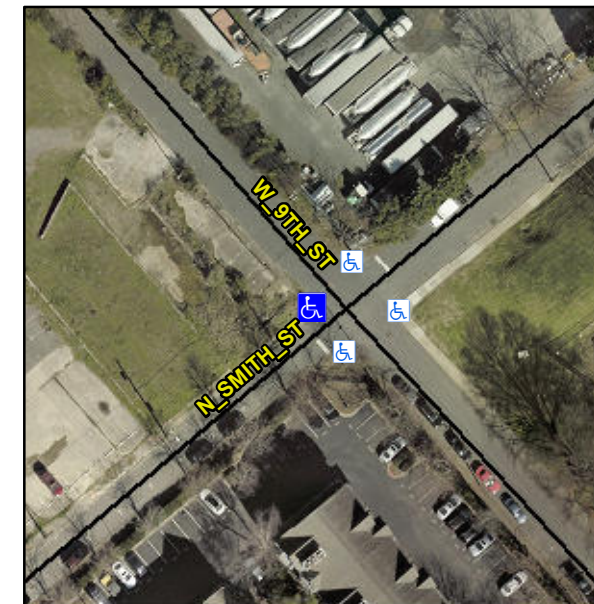
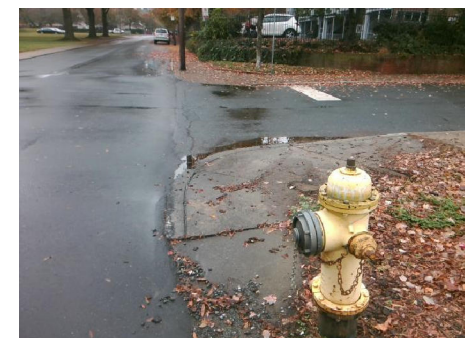
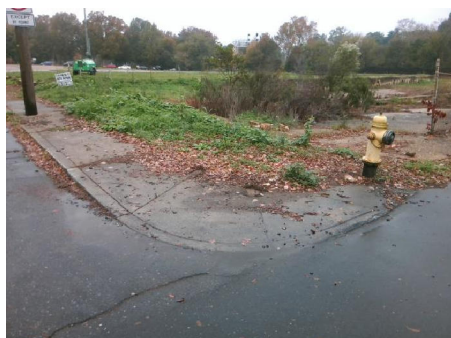
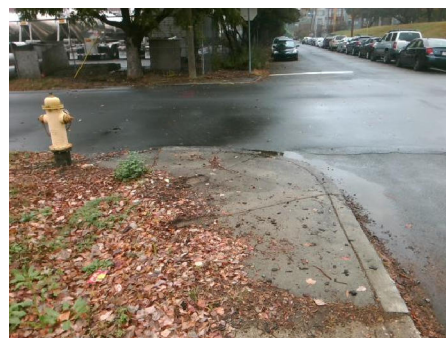
Compliance	Description	Data	Compliance	Description	Data
N/A	Ramp Length (in)	64.0	Yes	BlendTrans Slope (%)	1.1
No	Ramp Width (in)	37.0	Yes	BlendTrans XSlope (%)	1.7
N/A	Flare Type LT	N/A	N/A	Flare Type RT	N/A
N/A	Flare Slope LT (%)	N/A	N/A	Flare Slope RT (%)	N/A
N/A	Flare Traversable LT?	N/A	N/A	Flare Traversable RT?	N/A
N/A	Landing Length (in)	N/A	N/A	DWS Provided?	N/A
N/A	Landing Width (in)	N/A	N/A	DWS Contrast?	N/A
N/A	Landing Slope (%)	N/A	N/A	DWS Length (in)	N/A
N/A	Landing X Slope (%)	N/A	N/A	DWS Full Width?	N/A
N/A	Landing Curb? (Y/N)	N/A	N/A	DWS Offset (in)	N/A
N/A	Shared Landing?	N/A			
N/A	Gutter Ponding?	Yes	N/A	Gutter Slope (%)	N/A
N/A	Gutter Lip Ht (in)	N/A	N/A	Gutter X Slope (%)	N/A
N/A	Painted X Walk1?	No	N/A	Painted X Walk2?	No
	X Walk 1 Direction	To SE		X Walk 2 Direction	To NE
	X Walk 1 Width (in)	N/A		X Walk 2 Width (in)	N/A
	X Walk 1 Slope (%)	1.9		X Walk 2 Slope (%)	2.0
	X Walk 1 X Slope (%)	0.7		X Walk 2 X Slope (%)	2.3

N/A	Ramp inside XWalk1?	N/A	N/A	Ramp inside XWalk2?	N/A
	Road Slope (%)	2.5		Clear Space?	N/A
	Road X Slope (%)	3.0	N/A	Clear Space to XWalk (in)	N/A
N/A	Any Obstructions?	N/A	N/A	Storm Grate/Utility Hazard?	N/A
	Obstruction Type			Storm Grate/Utility Type	
		N/A			N/A
		Yes		Surface Condition? (G/P)	Good
		N/A		Curb Slope (%)	N/A

**Remove & Replace Curb Ramp With Two New Directional Ramps or Equivalent.**

**R304.5.1**
