| Intersection ID: 53840 | Main Street: LEWIS_ST | Cross Street: CLARK_BV | Location: | N |
| ADA ID: 8E84ADB31C1A | Ramp Type: BlendTrans1 | Initial Pass/Fail: Fail | Overall Compliance: No | Severity Score: 21.25 |

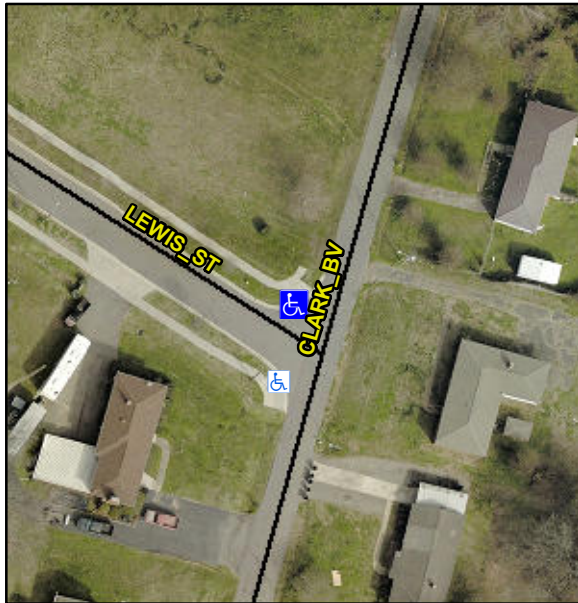
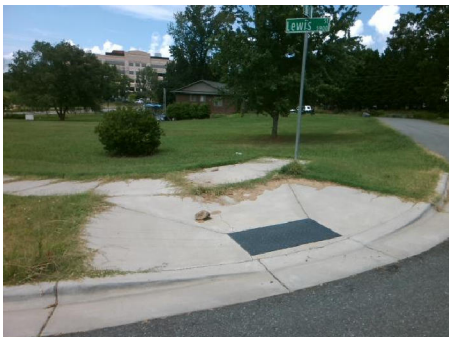
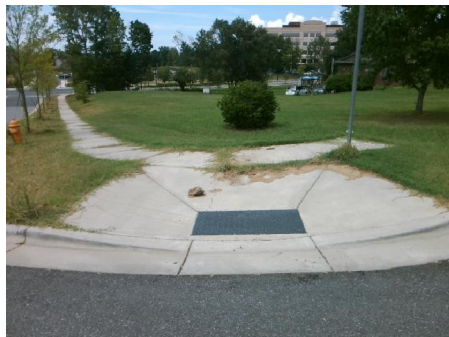
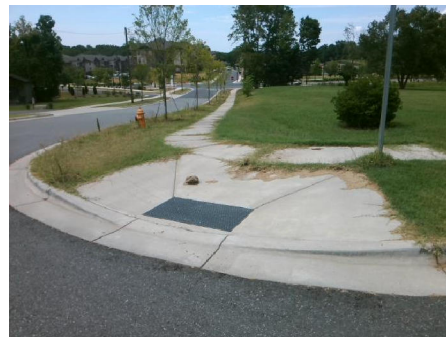
**Not Found, R304.5.1, R304.5.3**

| Compliance | Description | Data | Compliance | Description | Data |
|---|---|---|---|---|---|
| No | Ramp Width (in) | 47.0 | No | BlendTrans XSlope (%) | 5.6 |
| | | | No | Curb Slope (%) | 18.7 |

**Remove & Replace Curb Ramp With Two New Directional Ramps or Equivalent.**

Total Cost: \$ 3200.00
