Access Compliance Report Public Rights-of-Way (Curb Ramps)

Intersection ID: 7305 Main Street: BEATTIES_FORD_RD Cross Street: LYNCHESTER_PL Location: SW

ADA ID: 8E85A41DD03B Ramp Type: ParaDiag Initial Pass/Fail: Fail Overall Compliance: No Severity Score: 13.75

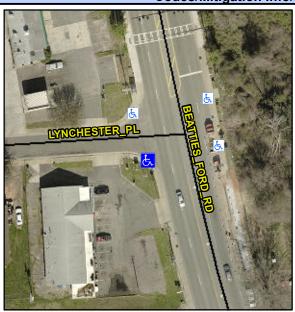
Compliance Description Date		Data	Compliance Description		Data
N/A	Ramp Length LT (in)	59.0	N/A	Ramp Length RT (in)	53.0
Yes	Ramp Width LT (in)	72.0	Yes	Ramp Width RT (in)	72.0
No	Ramp Slope LT (%)	8.5	Yes	Ramp Slope RT (%)	5.5
No	Ramp XSlope LT (%)	2.2	Yes	Ramp XSlope RT (%)	1.0
N/A	Landing Length (in)	N/A	N/A	DWS Provided?	N/A
N/A	Landing Width (in)	N/A	N/A	DWS Contrast?	N/A
N/A	Landing Slope (%)	N/A	N/A	DWS Length (in)	N/A
N/A	Landing X Slope (%)	N/A	N/A	DWS Full Width?	N/A
N/A	Landing Curb? (Y/N)	N/A	N/A	DWS Offset (in)	N/A
N/A	Shared Landing?	N/A			
N/A	Gutter Ponding?	N/A	N/A	Gutter Slope (%)	N/A
N/A	Gutter Lip Ht (in)	N/A	N/A	Gutter X Slope (%)	N/A
N/A	Painted X Walk1?	No	N/A	Painted X Walk2?	No
	X Walk 1 Direction	To E		X Walk 2 Direction	To N
N/A	X Walk 1 Width (in)	N/A	N/A	X Walk 2 Width (in)	N/A
	X Walk 1 Slope (%)	0.3		X Walk 2 Slope (%)	0.8
	X Walk 1 X Slope (%)	1.7		X Walk 2 X Slope (%)	1.6
N/A	Ramp inside XWalk1?	N/A	N/A	Ramp inside XWalk2?	N/A

Road Slope (%)	0.1	N/A	Clear Space?	N/A
	Road X Slope (%)	0.1	N/A	Clear Space to XWalk (in)	N/A
N/A	Any Obstructions?	N/A	N/A	Storm Grate/Utility Hazard?	N/A
	Obstruction Type			Storm Grate/Utility Type	
		N/A			N/A
			Yes	Surface Condition? (G/P)	Good
			N/A	Curb Slope (%)	13.7
4	HE WHO MACE

Remove & Replace Curb Ramp With Two New Directional Ramps or Equivalent.
