# Access Compliance Report

## Public Rights-of-Way

### (Curb Ramps)

| Intersection ID: 50100 | Main Street: PECAN_FLATS_DR | Cross Street: SUNRISE_VIEW_DR | Location: SW |

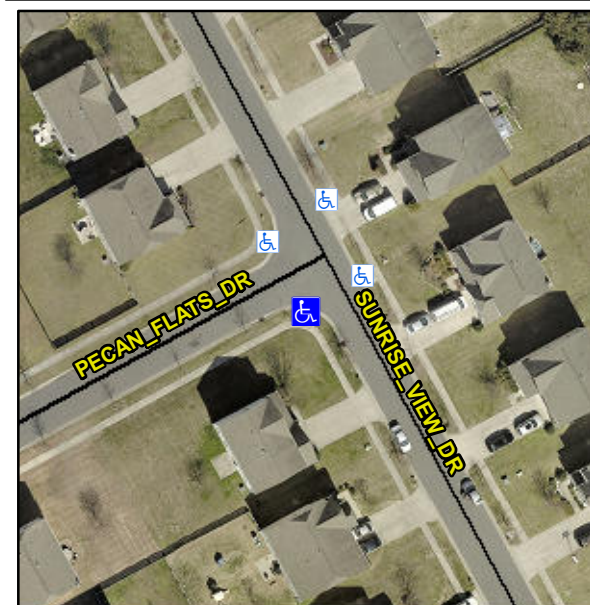
| ADA ID: 8E86C6052E7D | Ramp Type: BlendTrans1 | Initial Pass/Fail: Fail | Overall Compliance: No |
| Severity Score: 8.75 | | | |

**Not Found, R304.5.1**

| Compliance | Description | Data | Compliance | Description | Data |
|---|---|---|---|---|---|
| No | Ramp Width (in) | 47.0 | Yes | BlendTrans XSlope (%) | 1.8 |
| | | | No | Curb Slope (%) | 11.9 |

**Remove & Replace Curb Ramp With Two New Directional Ramps or Equivalent.**

Total Cost: \$ 3200.00
