Access Compliance Report

Public Rights-of-Way

(Curb Ramps)

Intersection ID: 13644	Main Street: BEECH_NUT_RD	Cross Street: WEST_BV	Location: SE
ADA ID: 8E8B79464582	Ramp Type: Perpendicular Diagonal	Initial Pass/Fail: Fail	Overall Compliance: No
Severity Score: 21.25			
Codes/Mitigation Info/Possible Solution		Field Measurements/Component Compliance

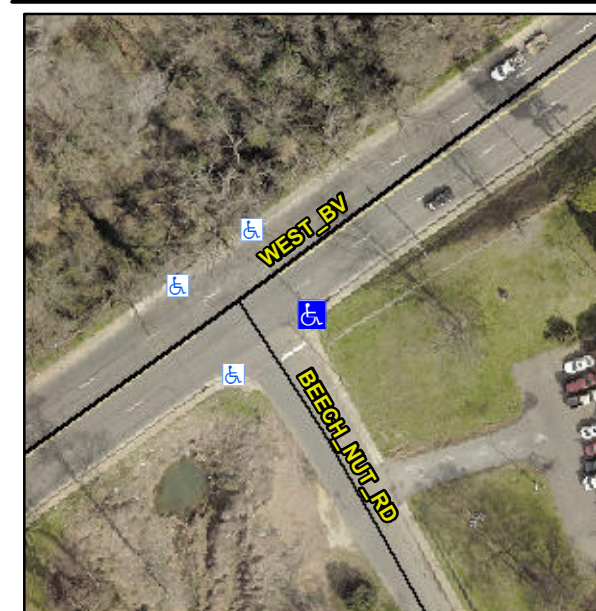
Not Found, R304.5.1, R304.5.3

Compliance	Description	Data	Compliance	Description	Data
N/A	Ramp Length (in)	55.0	Yes	Ramp Slope (%)	8.0
No	Ramp Width (in)	42.0	No	Ramp XSlope (%)	6.3
N/A	Flare Type LT	N/A	N/A	Flare Type RT	N/A
N/A	Flare Slope LT (%)	N/A	N/A	Flare Slope RT (%)	N/A
N/A	Flare Traversable LT?	N/A	N/A	Flare Traversable RT?	N/A
N/A	Landing Length (in)	N/A	N/A	DWS Provided?	N/A
N/A	Landing Width (in)	N/A	N/A	DWS Contrast?	N/A
N/A	Landing Slope (%)	N/A	N/A	DWS Length (in)	N/A
N/A	Landing X Slope (%)	N/A	N/A	DWS Full Width?	N/A
N/A	Landing Curb? (Y/N)	N/A	N/A	DWS Offset (in)	N/A
N/A	Shared Landing?	N/A			
N/A	Gutter Ponding?	N/A	N/A	Gutter Slope (%)	N/A
N/A	Gutter Lip Ht (in)	N/A	N/A	Gutter X Slope (%)	N/A
N/A	Painted X Walk1?	No	N/A	Painted X Walk2?	No
	X Walk 1 Direction	To N		X Walk 2 Direction	To SW
N/A	X Walk 1 Width (in)	N/A	N/A	X Walk 2 Width (in)	N/A
	X Walk 1 Slope (%)	5.6		X Walk 2 Slope (%)	1.7
	X Walk 1 X Slope (%)	0.3		X Walk 2 X Slope (%)	3.6

N/A	Ramp inside XWalk1?	N/A	N/A	Ramp inside XWalk2?	N/A
	Road Slope (%)	1.8	N/A	Clear Space?	N/A
	Road X Slope (%)	4.4	N/A	Clear Space to XWalk (in)	N/A
N/A	Any Obstructions?	N/A	N/A	Storm Grate/Utility Hazard?	N/A
	Obstruction Type			Storm Grate/Utility Type	
		N/A			N/A
		Yes		Surface Condition? (G/P)	Good

Remove & Replace Curb Ramp With Two New Directional Ramps or Equivalent.
