Access Compliance Report

Public Rights-of-Way

(Curb Ramps)

Intersection ID: 48714	Main Street: SARDIS_CREEK_LN	Cross Street: KILCULLEN_DR	Location: E
ADA ID: 8E8BDF7BB8DB	Ramp Type: Perpendicular Diagonal	Initial Pass/Fail: Fail	Overall Compliance: No
			Severity Score: 33.75

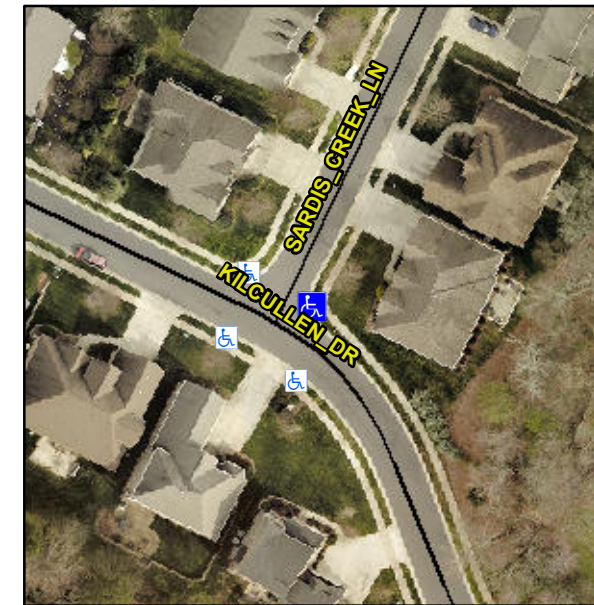
Compliance	Description	Data	Compliance	Description	Data
N/A	Ramp Length (in)	52.0	Yes	Ramp Slope (%)	7.1
No	Ramp Width (in)	43.0	No	Ramp XSlope (%)	9.4
N/A	Flare Type LT	N/A	N/A	Flare Type RT	N/A
N/A	Flare Slope LT (%)	N/A	N/A	Flare Slope RT (%)	N/A
N/A	Flare Traversable LT?	N/A	N/A	Flare Traversable RT?	N/A
N/A	Landing Length (in)	N/A	N/A	DWS Provided?	N/A
N/A	Landing Width (in)	N/A	N/A	DWS Contrast?	N/A
N/A	Landing Slope (%)	N/A	N/A	DWS Length (in)	N/A
N/A	Landing X Slope (%)	N/A	N/A	DWS Full Width?	N/A
N/A	Landing Curb? (Y/N)	N/A	N/A	DWS Offset (in)	N/A
N/A	Shared Landing?	N/A			
N/A	Gutter Ponding?	N/A	N/A	Gutter Slope (%)	N/A
N/A	Gutter Lip Ht (in)	N/A	N/A	Gutter X Slope (%)	N/A
N/A	Painted X Walk1?	No	N/A	Painted X Walk2?	No
	X Walk 1 Direction	To NW		X Walk 2 Direction	To SW
N/A	X Walk 1 Width (in)	N/A	N/A	X Walk 2 Width (in)	N/A
	X Walk 1 Slope (%)	2.0		X Walk 2 Slope (%)	5.9
	X Walk 1 X Slope (%)	4.9		X Walk 2 X Slope (%)	5.6

N/A	Ramp inside XWalk1?	N/A	N/A	Ramp inside XWalk2?	N/A
	Road Slope (%)	7.9	N/A	Clear Space?	N/A
	Road X Slope (%)	1.2	N/A	Clear Space to XWalk (in)	N/A
N/A	Any Obstructions?	N/A	N/A	Storm Grate/Utility Hazard?	N/A
	Obstruction Type			Storm Grate/Utility Type	
		N/A			N/A
			Yes	Surface Condition? (G/P)	Good

Remove & Replace Curb Ramp With Two New Directional Ramps or Equivalent.

R304.5.1, R304.5.3
