# Access Compliance Report

## Public Rights-of-Way

### (Curb Ramps)

Intersection ID: N/A	Main Street: YORKMONT_RD	Cross Street: N/A	Location: N
ADA ID: 8E8E3D5694E1	Ramp Type: Perpendicular Diagonal	Initial Pass/Fail: Fail	Overall Compliance: No
		Severity Score: 27.5

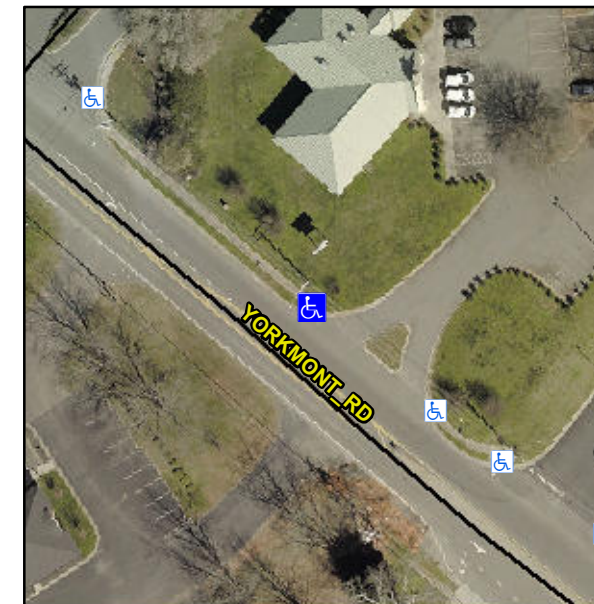
Compliance	Description	Data	Compliance	Description	Data
N/A	Ramp Length (in)	32.0	No	Ramp Slope (%)	8.6
Yes	Ramp Width (in)	48.0	Yes	Ramp XSlope (%)	1.6
N/A	Flare Type LT	N/A	N/A	Flare Type RT	N/A
N/A	Flare Slope LT (%)	N/A	N/A	Flare Slope RT (%)	N/A
N/A	Flare Traversable LT?	N/A	N/A	Flare Traversable RT?	N/A
N/A	Landing Length (in)	N/A	N/A	DWS Provided?	N/A
N/A	Landing Width (in)	N/A	N/A	DWS Contrast?	N/A
N/A	Landing Slope (%)	N/A	N/A	DWS Length (in)	N/A
N/A	Landing X Slope (%)	N/A	N/A	DWS Full Width?	N/A
N/A	Landing Curb? (Y/N)	N/A	N/A	DWS Offset (in)	N/A
N/A	Shared Landing?	N/A			
N/A	Gutter Ponding?	N/A	N/A	Gutter Slope (%)	N/A
N/A	Gutter Lip Ht (in)	N/A	N/A	Gutter X Slope (%)	N/A
N/A	Painted X Walk1?	No	N/A	Painted X Walk2?	No
	X Walk 1 Direction	To SW		X Walk 2 Direction	To SE
N/A	X Walk 1 Width (in)	N/A	N/A	X Walk 2 Width (in)	N/A
	X Walk 1 Slope (%)	1.4		X Walk 2 Slope (%)	0.2
	X Walk 1 X Slope (%)	0.1		X Walk 2 X Slope (%)	2.2

N/A	Ramp inside XWalk1?	N/A	N/A	Ramp inside XWalk2?	N/A
	Road Slope (%)	0.6	N/A	Clear Space?	N/A
	Road X Slope (%)	0.1	N/A	Clear Space to XWalk (in)	N/A
N/A	Any Obstructions?	N/A	N/A	Storm Grate/Utility Hazard?	N/A
	Obstruction Type			Storm Grate/Utility Type	
		N/A			N/A
		No		Surface Condition? (G/P)	Poor

**Remove & Replace Curb Ramp With Two New Directional Ramps or Equivalent.**

**R304.2.2, R302.7**
