Access Compliance Report

Public Rights-of-Way

(Curb Ramps)

Intersection ID: 47611	Main Street: WYALONG_DR	Cross Street: MINTWORTH_AV	Location: SW
ADA ID: 8E90E1CF4948	Ramp Type: Perpendicular	Initial Pass/Fail: Fail	Overall Compliance: No
Severity Score: 12.5			
Codes/Mitigation Info/Possible Solution		Field Measurements/Component Compliance

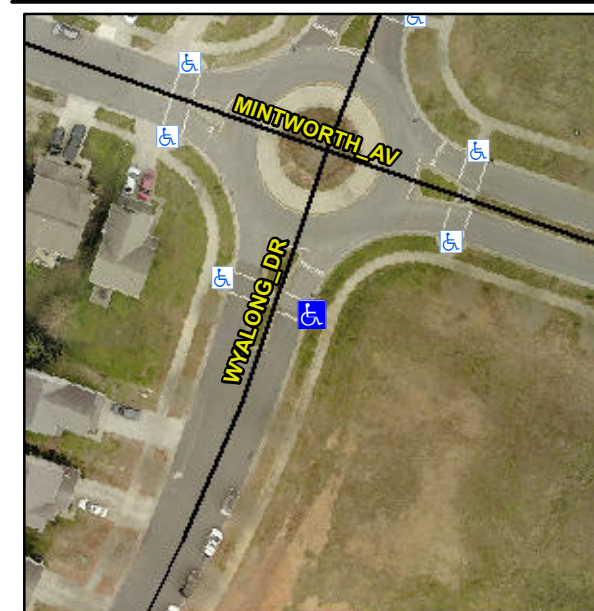
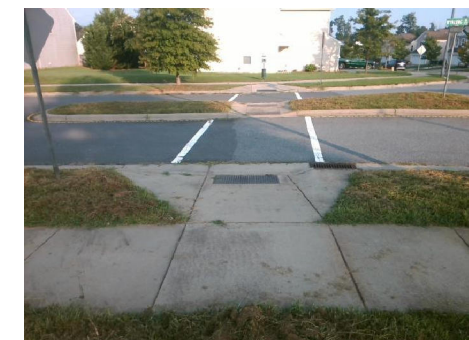
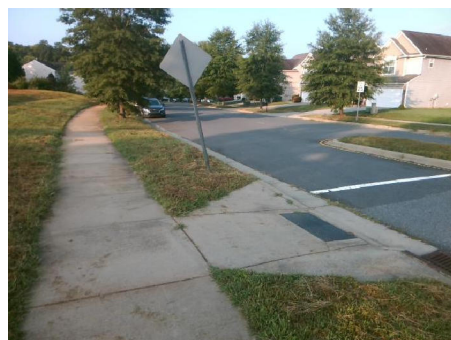
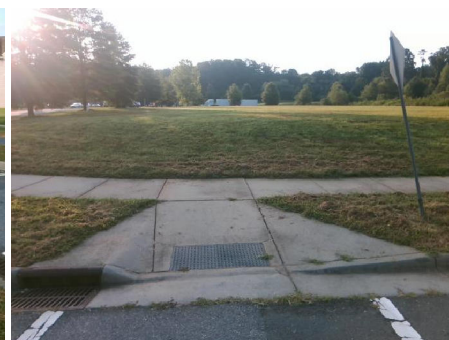
Not Found, R304.2.2

Compliance	Description	Data	Compliance	Description	Data
N/A	Ramp Length (in)	96.0	No	Ramp Slope (%)	9.4
Yes	Ramp Width (in)	62.0	Yes	Ramp XSlope (%)	1.8
N/A	Flare Type LT	N/A	N/A	Flare Type RT	N/A
N/A	Flare Slope LT (%)	N/A	N/A	Flare Slope RT (%)	N/A
N/A	Flare Traversable LT?	N/A	N/A	Flare Traversable RT?	N/A
N/A	Landing Length (in)	N/A	N/A	DWS Provided?	N/A
N/A	Landing Width (in)	N/A	N/A	DWS Contrast?	N/A
N/A	Landing Slope (%)	N/A	N/A	DWS Length (in)	N/A
N/A	Landing X Slope (%)	N/A	N/A	DWS Full Width?	N/A
N/A	Landing Curb? (Y/N)	N/A	N/A	DWS Offset (in)	N/A
N/A	Shared Landing?	N/A			
N/A	Gutter Ponding?	N/A	N/A	Gutter Slope (%)	N/A
N/A	Gutter Lip Ht (in)	N/A	N/A	Gutter X Slope (%)	N/A
N/A	Painted X Walk1?	Yes	N/A	Painted X Walk2?	N/A
	X Walk 1 Direction	To NW		X Walk 2 Direction	N/A
N/A	X Walk 1 Width (in)	119.0	N/A	X Walk 2 Width (in)	N/A
	X Walk 1 Slope (%)	4.6		X Walk 2 Slope (%)	N/A
	X Walk 1 X Slope (%)	2.0		X Walk 2 X Slope (%)	N/A

N/A	Ramp inside XWalk1?	Yes	N/A	Ramp inside XWalk2?	N/A
	Road Slope (%)	N/A	N/A	Clear Space?	N/A
	Road X Slope (%)	N/A	N/A	Clear Space to XWalk (in)	N/A
N/A	Any Obstructions?	N/A	N/A	Storm Grate/Utility Hazard?	N/A
	Obstruction Type			Storm Grate/Utility Type	
		N/A			N/A
		Yes		Surface Condition? (G/P)	Good

Remove & Replace Entire Ramp.
