# Access Compliance Report

## Public Rights-of-Way

### (Curb Ramps)

Intersection ID: 7885	Main Street: MONTANA_DR	Cross Street: BEATTIES_FORD_RD	Location: SE
ADA ID: 8E98136D77CC	Ramp Type: Perpendicular	Initial Pass/Fail: Fail	Overall Compliance: No
Severity Score: 21.25			
Codes/Mitigation Info/Possible Solution		Field Measurements/Component Compliance

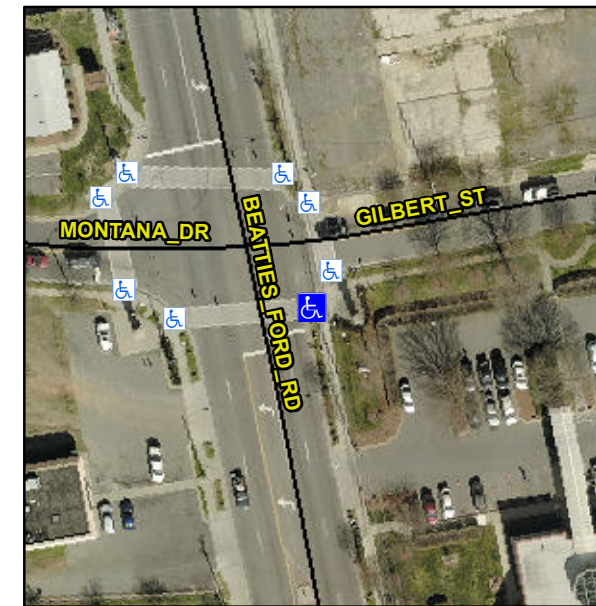
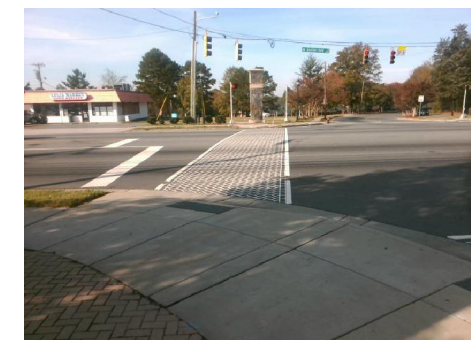
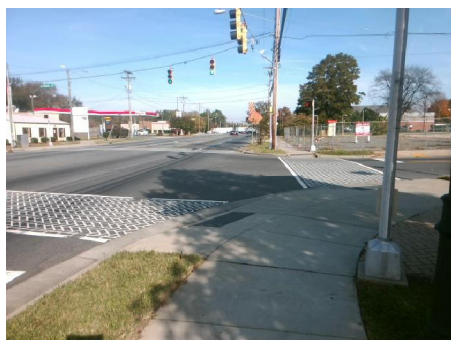
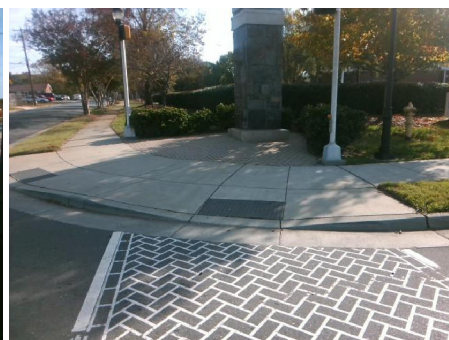
**Not Found, R304.5.1, R304.2.2**

Compliance	Description	Data	Compliance	Description	Data
N/A	Ramp Length (in)	48.5	No	Ramp Slope (%)	10.8
No	Ramp Width (in)	45.0	Yes	Ramp XSlope (%)	1.1
N/A	Flare Type LT	N/A	N/A	Flare Type RT	N/A
N/A	Flare Slope LT (%)	N/A	N/A	Flare Slope RT (%)	N/A
N/A	Flare Traversable LT?	N/A	N/A	Flare Traversable RT?	N/A
N/A	Landing Length (in)	N/A	N/A	DWS Provided?	N/A
N/A	Landing Width (in)	N/A	N/A	DWS Contrast?	N/A
N/A	Landing Slope (%)	N/A	N/A	DWS Length (in)	N/A
N/A	Landing X Slope (%)	N/A	N/A	DWS Full Width?	N/A
N/A	Landing Curb? (Y/N)	N/A	N/A	DWS Offset (in)	N/A
N/A	Shared Landing?	N/A			
N/A	Gutter Ponding?	N/A	N/A	Gutter Slope (%)	N/A
N/A	Gutter Lip Ht (in)	N/A	N/A	Gutter X Slope (%)	N/A
N/A	Painted X Walk1?	Yes	N/A	Painted X Walk2?	N/A
	X Walk 1 Direction	To W		X Walk 2 Direction	N/A
N/A	X Walk 1 Width (in)	120.5	N/A	X Walk 2 Width (in)	N/A
	X Walk 1 Slope (%)	1.2		X Walk 2 Slope (%)	N/A
	X Walk 1 X Slope (%)	1.1		X Walk 2 X Slope (%)	N/A

N/A	Ramp inside XWalk1?	Yes	N/A	Ramp inside XWalk2?	N/A
	Road Slope (%)	N/A	N/A	Clear Space?	N/A
	Road X Slope (%)	N/A	N/A	Clear Space to XWalk (in)	N/A
N/A	Any Obstructions?	N/A	N/A	Storm Grate/Utility Hazard?	N/A
	Obstruction Type			Storm Grate/Utility Type	
		N/A			N/A
		Yes		Surface Condition? (G/P)	Good

**Remove & Replace Entire Ramp.**

Total Cost: \$ 1850.00
