Access Compliance Report

Public Rights-of-Way

(Curb Ramps)

Intersection ID: 27355	Main Street: JOHNSTON_RD	Cross Street: BRIXHAM_AV	Location: NE
ADA ID: 8E9ADD38D0DE	Ramp Type: Perpendicular Diagonal	Initial Pass/Fail: Fail	Overall Compliance: No
Severity Score: 22.5			
Codes/Mitigation Info/Possible Solution		Field Measurements/Component Compliance

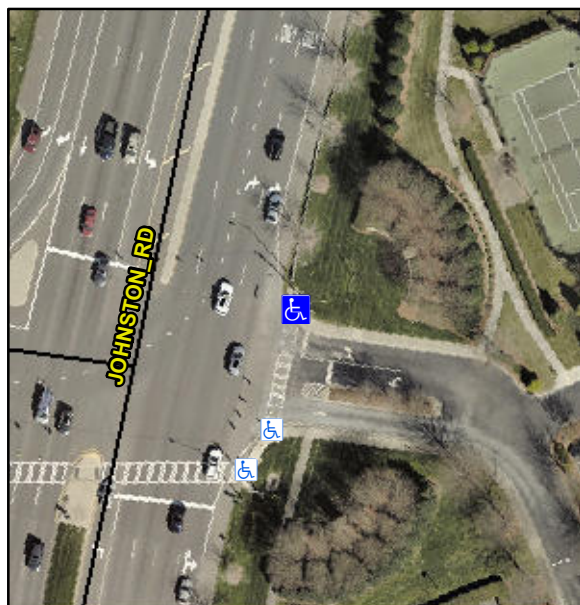
Compliance	Description	Data	Compliance	Description	Data
N/A	Ramp Length (in)	61.0	No	Ramp Slope (%)	9.2
No	Ramp Width (in)	41.0	No	Ramp XSlope (%)	4.0
N/A	Flare Type LT	N/A	N/A	Flare Type RT	N/A
N/A	Flare Slope LT (%)	N/A	N/A	Flare Slope RT (%)	N/A
N/A	Flare Traversable LT?	N/A	N/A	Flare Traversable RT?	N/A
N/A	Landing Length (in)	N/A	N/A	DWS Provided?	N/A
N/A	Landing Width (in)	N/A	N/A	DWS Contrast?	N/A
N/A	Landing Slope (%)	N/A	N/A	DWS Length (in)	N/A
N/A	Landing X Slope (%)	N/A	N/A	DWS Full Width?	N/A
N/A	Landing Curb? (Y/N)	N/A	N/A	DWS Offset (in)	N/A
N/A	Shared Landing?	N/A			
N/A	Gutter Ponding?	N/A	N/A	Gutter Slope (%)	N/A
N/A	Gutter Lip Ht (in)	N/A	N/A	Gutter X Slope (%)	N/A
N/A	Painted X Walk1?	No	N/A	Painted X Walk2?	Yes
	X Walk 1 Direction	To NW		X Walk 2 Direction	To SW
N/A	X Walk 1 Width (in)	N/A	N/A	X Walk 2 Width (in)	75.0
	X Walk 1 Slope (%)	0.3		X Walk 2 Slope (%)	2.3
	X Walk 1 X Slope (%)	2.8		X Walk 2 X Slope (%)	1.1

N/A	Ramp inside XWalk1?	N/A	N/A	Ramp inside XWalk2?	Yes
	Road Slope (%)	2.6	N/A	Clear Space?	N/A
	Road X Slope (%)	2.0	N/A	Clear Space to XWalk (in)	N/A
N/A	Any Obstructions?	N/A	N/A	Storm Grate/Utility Hazard?	N/A
	Obstruction Type			Storm Grate/Utility Type	
		N/A			N/A
		Yes		Surface Condition? (G/P)	Good

Possible Solutions:

Remove & Replace Curb Ramp With Two New Directional Ramps or Equivalent.
