# Access Compliance Report

## Public Rights-of-Way

### (Curb Ramps)

Intersection ID: 9901	Main Street: HOOD_RD	Cross Street: KENTSHIRE_LN	Location:	N
ADA ID: 8E9E64DE1481	Ramp Type: Directional1	Initial Pass/Fail: Fail	Overall Compliance: No	Severity Score: 13.75

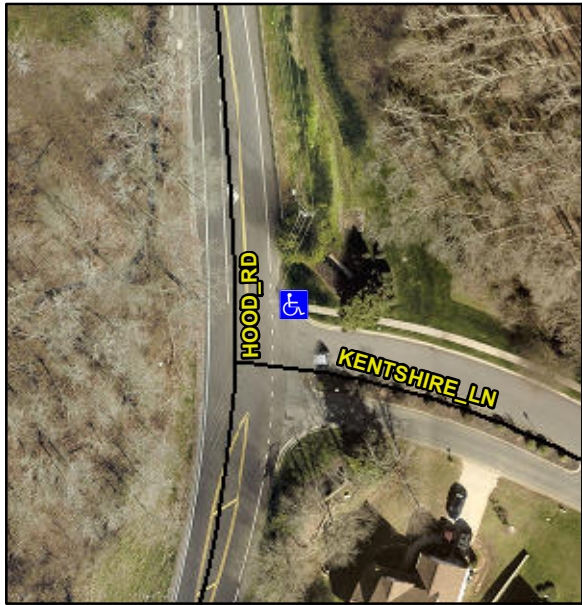
Possible Solutions:		<b>Compliance</b>			<b>Description</b>			<b>Data</b>		
	<b>Remove &amp; Replace Entire Ramp.</b>		<b>N/A</b>	Ramp Length (in)		<b>100.0</b>	<b>N/A</b>	Grade Break?		<b>N/A</b>	
			<b>Yes</b>	Ramp Width (in)		<b>48.0</b>	<b>N/A</b>	Grade Break Slope (%)		<b>0.0</b>	
			<b>No</b>	Ramp Slope (%)		<b>11.1</b>	<b>N/A</b>	Grade Break XSlope (%)		<b>0.0</b>	
			<b>No</b>	Ramp XSlope (%)		<b>4.3</b>					
			<b>N/A</b>	Flare Type LT		<b>N/A</b>	<b>N/A</b>	Flare Type RT		<b>N/A</b>	
			<b>N/A</b>	Flare Slope LT (%)		<b>N/A</b>	<b>N/A</b>	Flare Slope RT (%)		<b>0.0</b>	
			<b>N/A</b>	Flare Traversable LT?		<b>N/A</b>	<b>N/A</b>	Flare Traversable RT?		<b>N/A</b>	
			<b>N/A</b>	Landing Length (in)		<b>0.0</b>	<b>N/A</b>	DWS Provided?		<b>N/A</b>	
			<b>N/A</b>	Landing Width (in)		<b>0.0</b>	<b>N/A</b>	DWS Contrast?		<b>N/A</b>

<p>Surveyor Notes:</p> <p><b>N/A</b></p>			<b>N/A</b>	Landing Slope (%)		<b>0.0</b>	<b>N/A</b>	DWS Length (in)		<b>N/A</b>	
			<b>N/A</b>	Landing X Slope (%)		<b>0.0</b>	<b>N/A</b>	DWS Full Width?		<b>N/A</b>	
			<b>N/A</b>	Landing Curb? (Y/N)		<b>N/A</b>	<b>N/A</b>	DWS Offset LT (in)		<b>N/A</b>	
			<b>N/A</b>	Shared Landing?		<b>N/A</b>	<b>N/A</b>	DWS Offset RT (in)		<b>N/A</b>	
			<b>N/A</b>	Gutter Ponding?		<b>0.0</b>	<b>N/A</b>	Gutter Slope (%)		<b>N/A</b>	
			<b>N/A</b>	Gutter Lip Ht (in)		<b>2.0</b>	<b>N/A</b>	Gutter X Slope (%)		<b>N/A</b>	
			<b>N/A</b>	Painted X Walk1?		<b>No</b>		Road Slope (%)		<b>2.3</b>	
				X Walk 1 Direction		<b>To S</b>		Road X Slope (%)		<b>2.7</b>	
				X Walk 1 Width (in)		<b>N/A</b>		Clear Space?		<b>N/A</b>	
				X Walk 1 Slope (%)		<b>2.3</b>	<b>N/A</b>	Clear Space to XWalk (in)		<b>N/A</b>	
<p>PROW/ADA:</p> <p><b>R304.2.2, R304.5.3</b></p>				X Walk 1 X Slope (%)		<b>2.7</b>	<b>N/A</b>	Storm Grate/Utility Hazard?		<b>N/A</b>

<b>N/A</b>	Ramp inside XWalk1?		<b>N/A</b>		Storm Grate/Utility Type			
			<b>N/A</b>	Any Obstructions?		<b>N/A</b>				<b>N/A</b>	
				Obstruction Type			<b>Yes</b>	Surface Condition? (G/P)		<b>Good</b>	
							<b>N/A</b>	Curb Slope (%)		<b>15.8</b>	
Total Cost:			\$	<b>1600.00</b>
