Access Compliance Report

Public Rights-of-Way

(Curb Ramps)

Intersection ID: 24455	Main Street: S_TRYON_ST	Cross Street: STEELE_CREEK_RD	Location: SW
ADA ID: 8EA8A51443B0	Ramp Type: Perpendicular	Initial Pass/Fail: Fail	Overall Compliance: No
		Severity Score: 12.5

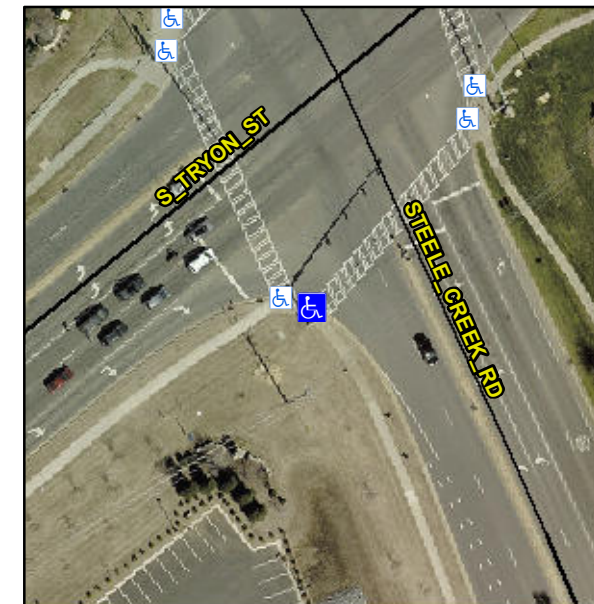
N/A

Compliance	Description	Data	Compliance	Description	Data
N/A	Ramp Length (in)	68.0	No	Ramp Slope (%)	9.1
Yes	Ramp Width (in)	48.0	Yes	Ramp XSlope (%)	0.6
N/A	Flare Type LT	N/A	N/A	Flare Type RT	N/A
N/A	Flare Slope LT (%)	N/A	N/A	Flare Slope RT (%)	N/A
N/A	Flare Traversable LT?	N/A	N/A	Flare Traversable RT?	N/A
N/A	Landing Length (in)	N/A	N/A	DWS Provided?	N/A
N/A	Landing Width (in)	N/A	N/A	DWS Contrast?	N/A
N/A	Landing Slope (%)	N/A	N/A	DWS Length (in)	N/A
N/A	Landing X Slope (%)	N/A	N/A	DWS Full Width?	N/A
N/A	Landing Curb? (Y/N)	N/A	N/A	DWS Offset (in)	N/A
N/A	Shared Landing?	N/A			
N/A	Gutter Ponding?	N/A	N/A	Gutter Slope (%)	N/A
N/A	Gutter Lip Ht (in)	N/A	N/A	Gutter X Slope (%)	N/A
N/A	Painted X Walk1?	Yes	N/A	Painted X Walk2?	N/A
	X Walk 1 Direction	To NE		X Walk 2 Direction	N/A
N/A	X Walk 1 Width (in)	120.0	N/A	X Walk 2 Width (in)	N/A
	X Walk 1 Slope (%)	2.5		X Walk 2 Slope (%)	N/A
	X Walk 1 X Slope (%)	1.1		X Walk 2 X Slope (%)	N/A

N/A	Ramp inside XWalk1?	Yes	N/A	Ramp inside XWalk2?	N/A
	Road Slope (%)	N/A	N/A	Clear Space?	N/A
	Road X Slope (%)	N/A	N/A	Clear Space to XWalk (in)	N/A
N/A	Any Obstructions?	N/A	N/A	Storm Grate/Utility Hazard?	N/A
	Obstruction Type			Storm Grate/Utility Type	
		N/A			N/A
		Yes		Surface Condition? (G/P)	Good

Possible Solutions:

Remove & Replace Entire Ramp.

R304.2.2
