Access Compliance Report

Public Rights-of-Way

(Curb Ramps)

Intersection ID: 10040668	Main Street: W MARTIN LUTHER KING JR BV	Cross Street: N/A	Location: E
ADA ID: 8EADDDE9410B	Ramp Type: Perp	Initial Pass/Fail: Fail	Overall Compliance: No
			Severity Score: 21.25

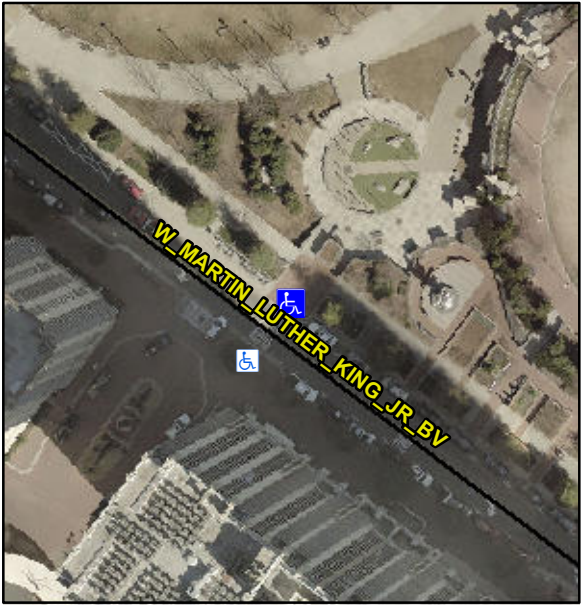
Compliance	Description	Data	Compliance	Description	Data
N/A	Ramp Length (in)	74.0	Yes	Ramp Slope (%)	6.2
No	Ramp Width (in)	47.0	No	Ramp XSlope (%)	6.8
N/A	Flare Type LT	N/A	N/A	Flare Type RT	N/A
N/A	Flare Slope LT (%)	N/A	N/A	Flare Slope RT (%)	N/A
N/A	Flare Traversable LT?	N/A	N/A	Flare Traversable RT?	N/A
N/A	Landing Length (in)	N/A	N/A	DWS Provided?	N/A
N/A	Landing Width (in)	N/A	N/A	DWS Contrast?	N/A
N/A	Landing Slope (%)	N/A	N/A	DWS Length (in)	N/A
N/A	Landing X Slope (%)	N/A	N/A	DWS Full Width?	N/A
N/A	Landing Curb? (Y/N)	N/A	N/A	DWS Offset (in)	N/A
N/A	Shared Landing?	N/A			
N/A	Gutter Ponding?	N/A	N/A	Gutter Slope (%)	N/A
N/A	Gutter Lip Ht (in)	N/A	N/A	Gutter X Slope (%)	N/A
N/A	Painted X Walk1?	Yes	N/A	Painted X Walk2?	N/A
	X Walk 1 Direction	To SW		X Walk 2 Direction	N/A
N/A	X Walk 1 Width (in)	112.0	N/A	X Walk 2 Width (in)	N/A
	X Walk 1 Slope (%)	1.1		X Walk 2 Slope (%)	N/A
	X Walk 1 X Slope (%)	4.8		X Walk 2 X Slope (%)	N/A

N/A	Ramp inside XWalk1?	Yes	N/A	Ramp inside XWalk2?	N/A
	Road Slope (%)	N/A	N/A	Clear Space?	N/A
	Road X Slope (%)	N/A	N/A	Clear Space to XWalk (in)	N/A
N/A	Any Obstructions?	N/A	N/A	Storm Grate/Utility Hazard?	N/A
	Obstruction Type			Storm Grate/Utility Type	
		N/A			N/A
			Yes	Surface Condition? (G/P)	Good

Possible Solutions:				
	Remove & Replace Entire Ramp.				
	Surveyor Notes:				
	N/A				
	PROW/ADA:				
	R304.5.1, R304.5.3				
Street 1 Name	W MARTIN LUTHER KING JR BV				
Stop Condition-Street 2	None				
Street 2 Name	N/A				
Stop Condition-Street 1	N/A				
Total Cost:		\$	1850.00
