# Access Compliance Report

## Public Rights-of-Way (Curb Ramps)

Intersection ID: 44929	Main Street: TWIN_BROOK_DR	Cross Street: NATHAN_DR	Location: W
ADA ID: 8EB57024B24A	Ramp Type: Perpendicular	Initial Pass/Fail: Fail	Overall Compliance: No
Severity Score: 8.75			
Codes/Mitigation Info/Possible Solution		Field Measurements/Component Compliance

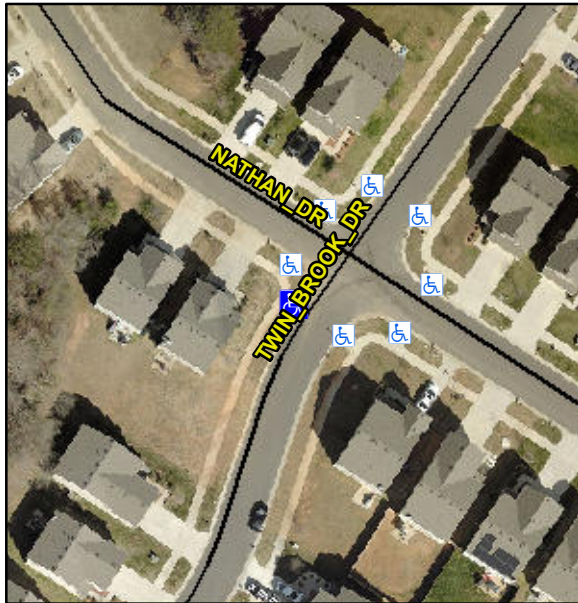
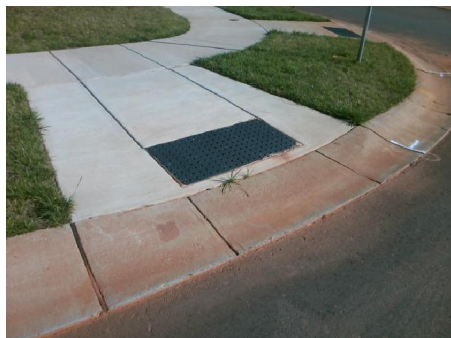
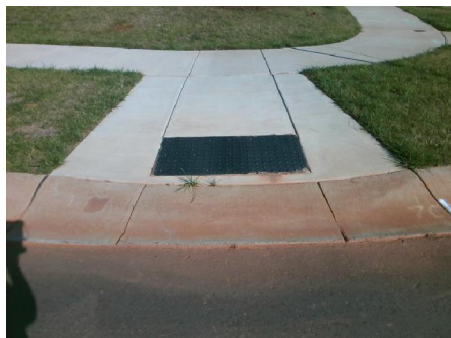
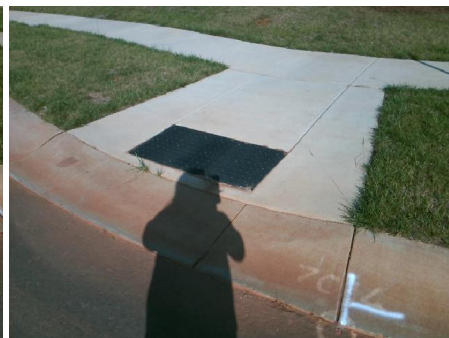
Compliance	Description	Data	Compliance	Description	Data
N/A	Ramp Length (in)	96.0	Yes	Ramp Slope (%)	6.9
No	Ramp Width (in)	43.0	Yes	Ramp XSlope (%)	0.1
N/A	Flare Type LT	N/A	N/A	Flare Type RT	N/A
N/A	Flare Slope LT (%)	N/A	N/A	Flare Slope RT (%)	N/A
N/A	Flare Traversable LT?	N/A	N/A	Flare Traversable RT?	N/A
N/A	Landing Length (in)	N/A	N/A	DWS Provided?	N/A
N/A	Landing Width (in)	N/A	N/A	DWS Contrast?	N/A
N/A	Landing Slope (%)	N/A	N/A	DWS Length (in)	N/A
N/A	Landing X Slope (%)	N/A	N/A	DWS Full Width?	N/A
N/A	Landing Curb? (Y/N)	N/A	N/A	DWS Offset (in)	N/A
N/A	Shared Landing?	N/A			
N/A	Gutter Ponding?	N/A	N/A	Gutter Slope (%)	N/A
N/A	Gutter Lip Ht (in)	N/A	N/A	Gutter X Slope (%)	N/A
N/A	Painted X Walk1?	No	N/A	Painted X Walk2?	N/A
	X Walk 1 Direction	To SE		X Walk 2 Direction	N/A
N/A	X Walk 1 Width (in)	N/A	N/A	X Walk 2 Width (in)	N/A
	X Walk 1 Slope (%)	4.6		X Walk 2 Slope (%)	N/A
	X Walk 1 X Slope (%)	0.3		X Walk 2 X Slope (%)	N/A

N/A	Ramp inside XWalk1?	N/A	N/A	Ramp inside XWalk2?	N/A
	Road Slope (%)	N/A	N/A	Clear Space?	N/A
	Road X Slope (%)	N/A	N/A	Clear Space to XWalk (in)	N/A
N/A	Any Obstructions?	N/A	N/A	Storm Grate/Utility Hazard?	N/A
	Obstruction Type			Storm Grate/Utility Type	
		N/A			N/A
			Yes	Surface Condition? (G/P)	Good

Possible Solutions:

**Remove & Replace Entire Ramp.**

**Not Found, R304.5.1**
