Access Compliance Report

Public Rights-of-Way

(Curb Ramps)

Intersection ID: 14076	Main Street: W_TYVOLA_RD	Cross Street: WEST_BV	Location: SE
ADA ID: 8EB747B2F40D	Ramp Type: ParaDiag	Initial Pass/Fail: Fail	Overall Compliance: No
Severity Score: 22.5			
Codes/Mitigation Info/Possible Solution		Field Measurements/Component Compliance

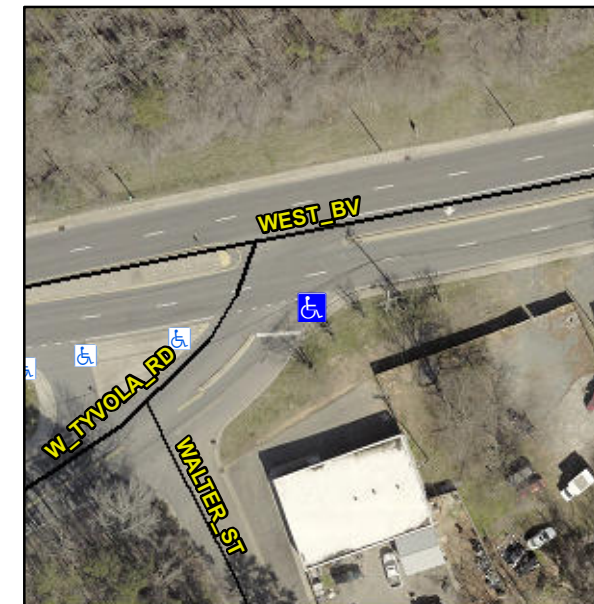
Compliance	Description	Data	Compliance	Description	Data
N/A	Ramp Length LT (in)	61.0	N/A	Ramp Length RT (in)	58.0
No	Ramp Width LT (in)	44.0	No	Ramp Width RT (in)	45.0
No	Ramp Slope LT (%)	9.4	Yes	Ramp Slope RT (%)	6.8
Yes	Ramp XSlope LT (%)	0.2	No	Ramp XSlope RT (%)	5.0
N/A	Landing Length (in)	N/A	N/A	DWS Provided?	N/A
N/A	Landing Width (in)	N/A	N/A	DWS Contrast?	N/A
N/A	Landing Slope (%)	N/A	N/A	DWS Length (in)	N/A
N/A	Landing X Slope (%)	N/A	N/A	DWS Full Width?	N/A
N/A	Landing Curb? (Y/N)	N/A	N/A	DWS Offset (in)	N/A
N/A	Shared Landing?	N/A			
N/A	Gutter Ponding?	N/A	N/A	Gutter Slope (%)	N/A
N/A	Gutter Lip Ht (in)	N/A	N/A	Gutter X Slope (%)	N/A
N/A	Painted X Walk1?	No	N/A	Painted X Walk2?	No
	X Walk 1 Direction	To N		X Walk 2 Direction	To W
N/A	X Walk 1 Width (in)	N/A	N/A	X Walk 2 Width (in)	N/A
	X Walk 1 Slope (%)	1.6		X Walk 2 Slope (%)	1.1
	X Walk 1 X Slope (%)	0.4		X Walk 2 X Slope (%)	6.1
N/A	Ramp inside XWalk1?	N/A	N/A	Ramp inside XWalk2?	N/A

Road Slope (%)	2.7	N/A	Clear Space?	N/A
	Road X Slope (%)	8.2	N/A	Clear Space to XWalk (in)	N/A
N/A	Any Obstructions?	N/A	N/A	Storm Grate/Utility Hazard?	N/A
	Obstruction Type			Storm Grate/Utility Type	
		N/A			N/A
			Yes	Surface Condition? (G/P)	Good
			N/A	Curb Slope (%)	11.0

Possible Solutions:

Remove & Replace Curb Ramp With Two New Directional Ramps or Equivalent.
