Access Compliance Report

Public Rights-of-Way

(Curb Ramps)

Intersection ID: 11617	Main Street: N_SMITH_ST	Cross Street: W_6TH_ST	Location:	E
ADA ID: 8EB8CF4C1E79	Ramp Type: Perpendicular Diagonal	Initial Pass/Fail: Fail	Overall Compliance: No	Severity Score: 12.5

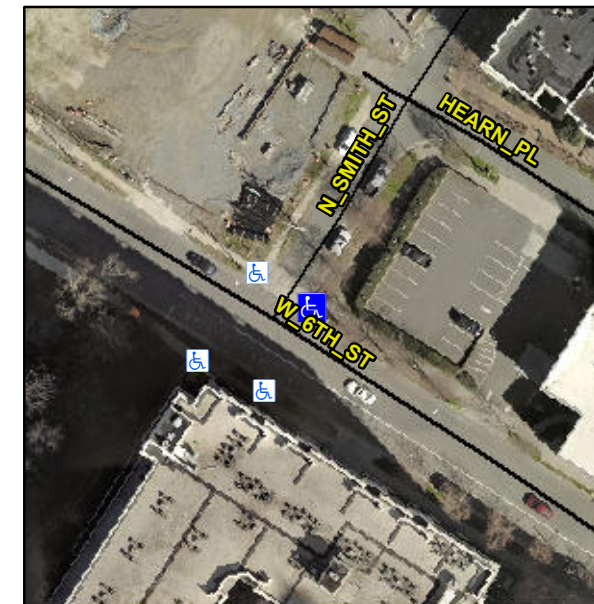
Not Found, R304.2.2

Compliance	Description	Data	Compliance	Description	Data
N/A	Ramp Length (in)	72.0	No	Ramp Slope (%)	9.3
Yes	Ramp Width (in)	48.0	Yes	Ramp XSlope (%)	1.3
N/A	Flare Type LT	N/A	N/A	Flare Type RT	N/A
N/A	Flare Slope LT (%)	N/A	N/A	Flare Slope RT (%)	N/A
N/A	Flare Traversable LT?	N/A	N/A	Flare Traversable RT?	N/A
N/A	Landing Length (in)	N/A	N/A	DWS Provided?	N/A
N/A	Landing Width (in)	N/A	N/A	DWS Contrast?	N/A
N/A	Landing Slope (%)	N/A	N/A	DWS Length (in)	N/A
N/A	Landing X Slope (%)	N/A	N/A	DWS Full Width?	N/A
N/A	Landing Curb? (Y/N)	N/A	N/A	DWS Offset (in)	N/A
N/A	Shared Landing?	N/A			
N/A	Gutter Ponding?	N/A	N/A	Gutter Slope (%)	N/A
N/A	Gutter Lip Ht (in)	N/A	N/A	Gutter X Slope (%)	N/A
N/A	Painted X Walk1?	No	N/A	Painted X Walk2?	No
	X Walk 1 Direction	To NW		X Walk 2 Direction	To SW
N/A	X Walk 1 Width (in)	N/A	N/A	X Walk 2 Width (in)	N/A
	X Walk 1 Slope (%)	0.9		X Walk 2 Slope (%)	5.8
	X Walk 1 X Slope (%)	3.8		X Walk 2 X Slope (%)	4.5

N/A	Ramp inside XWalk1?	N/A	N/A	Ramp inside XWalk2?	N/A
	Road Slope (%)	1.8	N/A	Clear Space?	N/A
	Road X Slope (%)	2.4	N/A	Clear Space to XWalk (in)	N/A
N/A	Any Obstructions?	N/A	N/A	Storm Grate/Utility Hazard?	N/A
	Obstruction Type			Storm Grate/Utility Type	
		N/A			N/A
			Yes	Surface Condition? (G/P)	Good

Remove & Replace Curb Ramp With Two New Directional Ramps or Equivalent.
