# Access Compliance Report

## Public Rights-of-Way

### (Curb Ramps)

| Intersection ID: N/A | Main Street: TAMARACK DR | Cross Street: SINGLELEAF LN | Location: S |

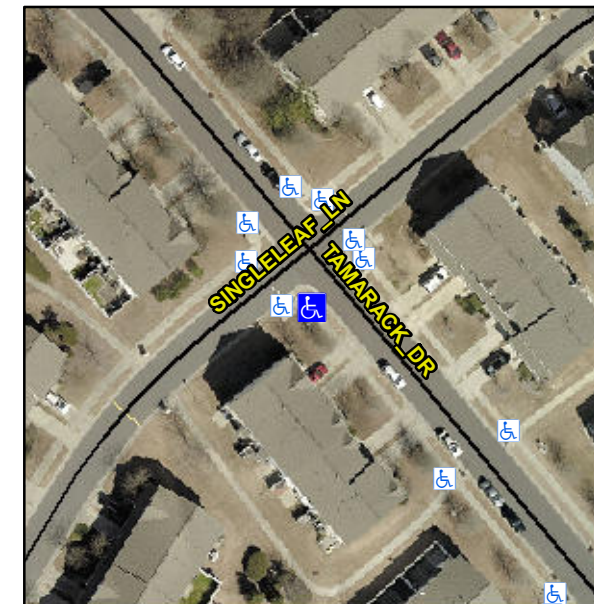
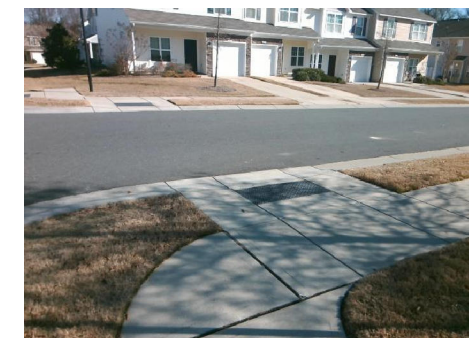
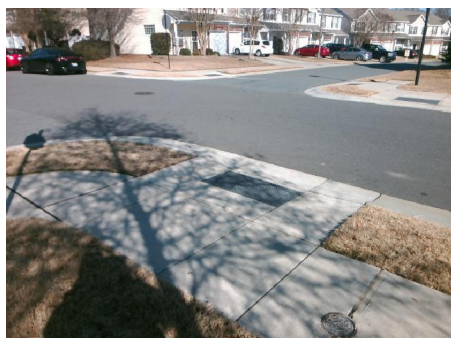
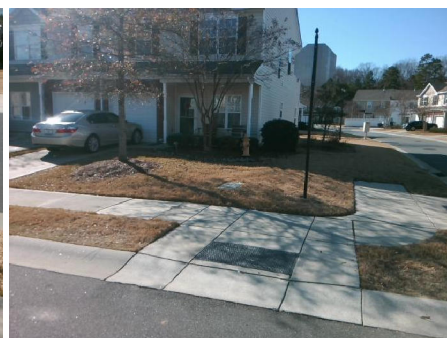
| ADA ID: 8ECF723A1464 | Ramp Type: Perpendicular | Initial Pass/Fail: Pass | Overall Compliance: No |

**Not Found, R304.5.3, R304.2.1,  
R304.2.2-Perp, R304.3.2-Para,  
R305.2**

| Compliance | Description | Data | Compliance | Description | Data |
|---|---|---|---|---|---|
| Yes | Ramp Width (in) | 48.0 | No | Ramp XSlope (%) | 2.5 |
| No | Landing Length (in) | 47.0 | Yes | DWS Provided? | Yes |
| No | Landing Slope (%) | 2.3 | Yes | DWS Length (in) | 24.0 |
| N/A | Landing Curb? (Y/N) | No | No | DWS Offset (in) | 4.5 |
| Yes | Gutter Lip Ht (in) | 0.0 | No | Gutter X Slope (%) | 2.4 |

**Remove & Replace Entire Ramp.  
Remove & Replace Gutter.**

Total Cost: \$ 2600.00
