Access Compliance Report

Public Rights-of-Way

(Curb Ramps)

Intersection ID: 28485	Main Street: REA_RD	Cross Street: WINDSOR RIDGE_DR	Location: SW
ADA ID: 8ED1A6923F6C	Ramp Type: Perpendicular	Initial Pass/Fail: Fail	Overall Compliance: No
Codes/Mitigation Info/Possible Solution			Severity Score: 10
			Field Measurements/Component Compliance

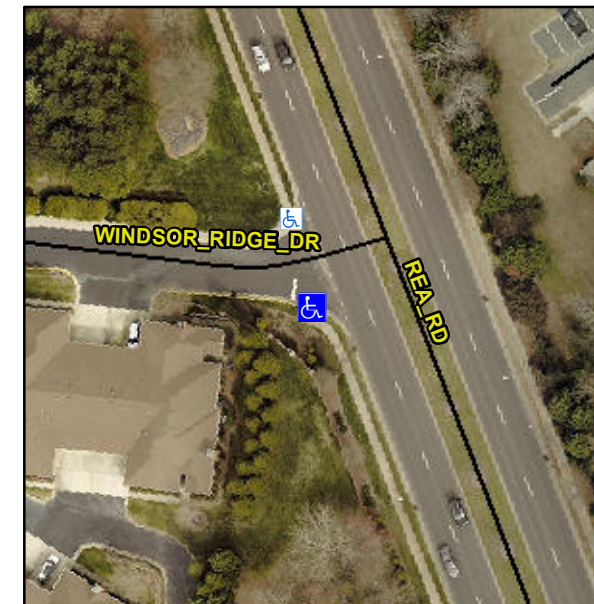
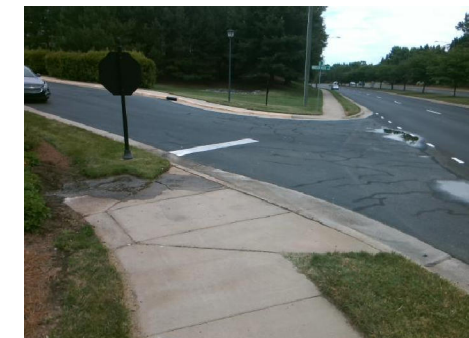
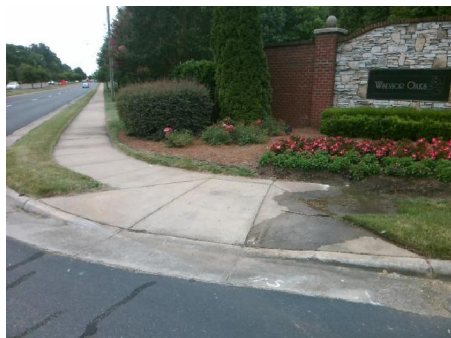
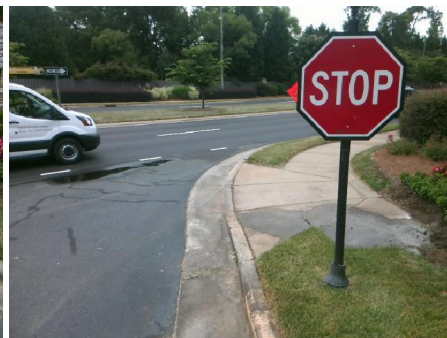
R304.5.1, R304.5.3

Compliance	Description	Data	Compliance	Description	Data
N/A	Ramp Length (in)	87.0	Yes	Ramp Slope (%)	5.8
No	Ramp Width (in)	44.5	No	Ramp XSlope (%)	3.9
N/A	Flare Type LT	N/A	N/A	Flare Type RT	N/A
N/A	Flare Slope LT (%)	N/A	N/A	Flare Slope RT (%)	N/A
N/A	Flare Traversable LT?	N/A	N/A	Flare Traversable RT?	N/A
N/A	Landing Length (in)	N/A	N/A	DWS Provided?	N/A
N/A	Landing Width (in)	N/A	N/A	DWS Contrast?	N/A
N/A	Landing Slope (%)	N/A	N/A	DWS Length (in)	N/A
N/A	Landing X Slope (%)	N/A	N/A	DWS Full Width?	N/A
N/A	Landing Curb? (Y/N)	N/A	N/A	DWS Offset (in)	N/A
N/A	Shared Landing?	N/A			
N/A	Gutter Ponding?	N/A	N/A	Gutter Slope (%)	N/A
N/A	Gutter Lip Ht (in)	N/A	N/A	Gutter X Slope (%)	N/A
N/A	Painted X Walk1?	No	N/A	Painted X Walk2?	N/A
	X Walk 1 Direction	To N		X Walk 2 Direction	N/A
N/A	X Walk 1 Width (in)	N/A	N/A	X Walk 2 Width (in)	N/A
	X Walk 1 Slope (%)	0.2		X Walk 2 Slope (%)	N/A
	X Walk 1 X Slope (%)	1.9		X Walk 2 X Slope (%)	N/A

N/A	Ramp inside XWalk1?	N/A	N/A	Ramp inside XWalk2?	N/A
	Road Slope (%)	N/A	N/A	Clear Space?	N/A
	Road X Slope (%)	N/A	N/A	Clear Space to XWalk (in)	N/A
N/A	Any Obstructions?	N/A	N/A	Storm Grate/Utility Hazard?	N/A
	Obstruction Type			Storm Grate/Utility Type	
		N/A			N/A
			Yes	Surface Condition? (G/P)	Good

Remove & Replace Entire Ramp.

Total Cost: \$ 1850.00
