Access Compliance Report

Public Rights-of-Way

(Curb Ramps)

Intersection ID: 10726	Main Street: AMBASSADOR_ST	Cross Street: STATE_ST	Location: W
ADA ID: 8ED6B6E89D9D	Ramp Type: Perpendicular	Initial Pass/Fail: Fail	Overall Compliance: No
Severity Score: 25			
Codes/Mitigation Info/Possible Solution		Field Measurements/Component Compliance

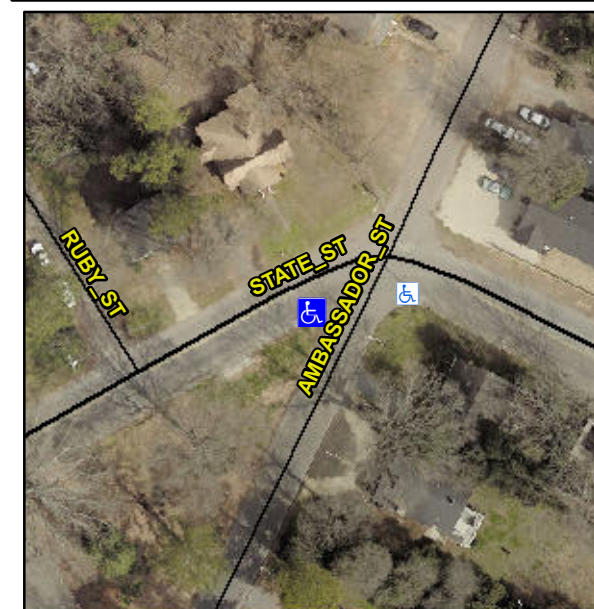
Compliance	Description	Data	Compliance	Description	Data
N/A	Ramp Length (in)	27.0	No	Ramp Slope (%)	10.1
Yes	Ramp Width (in)	55.0	No	Ramp XSlope (%)	6.6
N/A	Flare Type LT	N/A	N/A	Flare Type RT	N/A
N/A	Flare Slope LT (%)	N/A	N/A	Flare Slope RT (%)	N/A
N/A	Flare Traversable LT?	N/A	N/A	Flare Traversable RT?	N/A
N/A	Landing Length (in)	N/A	N/A	DWS Provided?	N/A
N/A	Landing Width (in)	N/A	N/A	DWS Contrast?	N/A
N/A	Landing Slope (%)	N/A	N/A	DWS Length (in)	N/A
N/A	Landing X Slope (%)	N/A	N/A	DWS Full Width?	N/A
N/A	Landing Curb? (Y/N)	N/A	N/A	DWS Offset (in)	N/A
N/A	Shared Landing?	N/A			
N/A	Gutter Ponding?	N/A	N/A	Gutter Slope (%)	N/A
N/A	Gutter Lip Ht (in)	N/A	N/A	Gutter X Slope (%)	N/A
N/A	Painted X Walk1?	No	N/A	Painted X Walk2?	N/A
	X Walk 1 Direction	To E		X Walk 2 Direction	N/A
N/A	X Walk 1 Width (in)	N/A	N/A	X Walk 2 Width (in)	N/A
	X Walk 1 Slope (%)	0.1		X Walk 2 Slope (%)	N/A
	X Walk 1 X Slope (%)	8.3		X Walk 2 X Slope (%)	N/A

N/A	Ramp inside XWalk1?	N/A	N/A	Ramp inside XWalk2?	N/A
	Road Slope (%)	N/A	N/A	Clear Space?	N/A
	Road X Slope (%)	N/A	N/A	Clear Space to XWalk (in)	N/A
N/A	Any Obstructions?	N/A	N/A	Storm Grate/Utility Hazard?	N/A
	Obstruction Type			Storm Grate/Utility Type	
		N/A			N/A
			Yes	Surface Condition? (G/P)	Good

Possible Solutions:

Remove & Replace Entire Ramp.

R304.2.2, R304.5.3
