Access Compliance Report

Public Rights-of-Way

(Curb Ramps)

Intersection ID: 50341	Main Street: SCONE_PALACE_CT	Cross Street: CASTLECOVE_RD	Location: NE
ADA ID: 8ED7C27DD01F	Ramp Type: Perpendicular Diagonal	Initial Pass/Fail: Fail	Overall Compliance: No
		Severity Score: 12.5

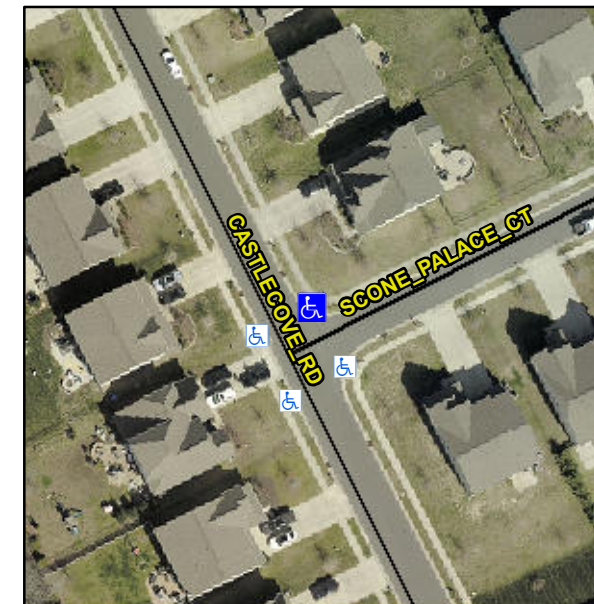
Compliance	Description	Data	Compliance	Description	Data
N/A	Ramp Length (in)	48.0	No	Ramp Slope (%)	9.4
Yes	Ramp Width (in)	48.0	Yes	Ramp XSlope (%)	1.6
N/A	Flare Type LT	N/A	N/A	Flare Type RT	N/A
N/A	Flare Slope LT (%)	N/A	N/A	Flare Slope RT (%)	N/A
N/A	Flare Traversable LT?	N/A	N/A	Flare Traversable RT?	N/A
N/A	Landing Length (in)	N/A	N/A	DWS Provided?	N/A
N/A	Landing Width (in)	N/A	N/A	DWS Contrast?	N/A
N/A	Landing Slope (%)	N/A	N/A	DWS Length (in)	N/A
N/A	Landing X Slope (%)	N/A	N/A	DWS Full Width?	N/A
N/A	Landing Curb? (Y/N)	N/A	N/A	DWS Offset (in)	N/A
N/A	Shared Landing?	N/A			
N/A	Gutter Ponding?	N/A	N/A	Gutter Slope (%)	N/A
N/A	Gutter Lip Ht (in)	N/A	N/A	Gutter X Slope (%)	N/A
N/A	Painted X Walk1?	No	N/A	Painted X Walk2?	No
	X Walk 1 Direction	To SW		X Walk 2 Direction	To SE
N/A	X Walk 1 Width (in)	N/A	N/A	X Walk 2 Width (in)	N/A
	X Walk 1 Slope (%)	3.0		X Walk 2 Slope (%)	0.6
	X Walk 1 X Slope (%)	0.9		X Walk 2 X Slope (%)	1.2

N/A	Ramp inside XWalk1?	N/A	N/A	Ramp inside XWalk2?	N/A
	Road Slope (%)	1.4	N/A	Clear Space?	N/A
	Road X Slope (%)	0.1	N/A	Clear Space to XWalk (in)	N/A
N/A	Any Obstructions?	N/A	N/A	Storm Grate/Utility Hazard?	N/A
	Obstruction Type			Storm Grate/Utility Type	
		N/A			N/A
			Yes	Surface Condition? (G/P)	Good

Possible Solutions:

Remove & Replace Curb Ramp With Two New Directional Ramps or Equivalent.

R304.2.2
