## Access Compliance Report Public Rights-of-Way (Curb Ramps)

Intersection ID: 50634Main Street:BLUE\_JASPER\_RDCross Street:CORAL\_ROSE\_RDLocation:SEADA ID: 8EE19751BE01Ramp Type:PerpendicularInitial Pass/Fail:PassOverall Compliance:NoSeverity Score:0

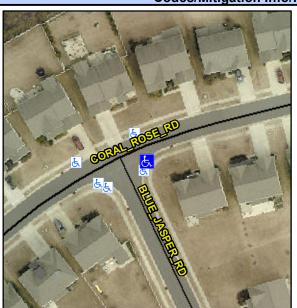
| Compliance Description | | Data | Comp | oliance Description | Data |
|---|---|---|---|---|---|
| No | Landing Slope (%) | 2.4 | Yes | DWS Length (in) | 24.0 |
| N/A | Landing Curb? (Y/N) | No | No | DWS Offset (in) | 5.5 |

| | Possible Solutions: |
|---|---|
| | Remove & Replace Entire Ramp. |
