## Access Compliance Report Public Rights-of-Way (Curb Ramps)

Intersection ID: 53252 Main Street: MARLOWE\_AV Cross Street: FLEETWOOD\_DR Location: SW

ADA ID: 8EE7096C973B Ramp Type: BlendTrans1 Initial Pass/Fail: Fail Overall Compliance: No Severity Score: 21.25

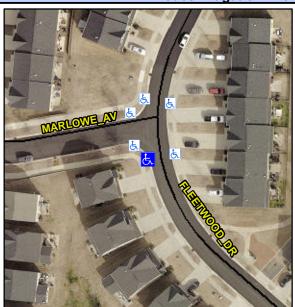
Not Found, R304.5.1, R304.5.3

Yes N/A Ramp Length (in) 60.0 BlendTrans Slope (%) 0.9 No No Ramp Width (in) 47.0 BlendTrans XSlope (%) 5.9 N/A N/A Flare Type LT N/A Flare Type RT N/A N/A Flare Slope LT (%) N/A N/A Flare Slope RT (%) N/A N/A Flare Traversable LT? N/A N/A Flare Traversable RT? N/A N/A Landing Length (in) N/A N/A DWS Provided? N/A N/A Landing Width (in) N/A N/A **DWS Contrast?** N/A N/A N/A N/A Landing Slope (%) DWS Length (in) N/A N/A Landing X Slope (%) N/A N/A DWS Full Width? N/A N/A Landing Curb? (Y/N) N/A N/A DWS Offset (in) N/A N/A N/A Shared Landing? N/A **Gutter Ponding?** N/A N/A Gutter Slope (%) N/A N/A Gutter Lip Ht (in) N/A N/A Gutter X Slope (%) N/A N/A Painted X Walk1? No N/A Painted X Walk2? N/A X Walk 1 Direction To E X Walk 2 Direction N/A N/A X Walk 1 Width (in) X Walk 2 Width (in) N/A X Walk 1 Slope (%) 4.5 X Walk 2 Slope (%) N/A X Walk 1 X Slope (%) 5.3 X Walk 2 X Slope (%) N/A N/A N/A Ramp inside XWalk2? N/A Ramp inside XWalk1? N/A Road Slope (%) 5.3 Clear Space? N/A N/A Road X Slope (%) Clear Space to XWalk (in) N/A 4.5 N/A N/A N/A Any Obstructions? Storm Grate/Utility Hazard? N/A **Obstruction Type** Storm Grate/Utility Type N/A N/A Yes Surface Condition? (G/P) Good No Curb Slope (%) 7.3

Remove & Replace Curb Ramp With Two New Directional Ramps or Equivalent.
